## Access Compliance Report Public Rights-of-Way (Curb Ramps)

Intersection ID: 14182 Main Street: E\_PARK\_AV Cross Street: LYNDHURST\_AV Location: N

ADA ID: 95D1FA494363 Ramp Type: Combination2 Initial Pass/Fail: Fail Overall Compliance: No Severity Score: 21.25

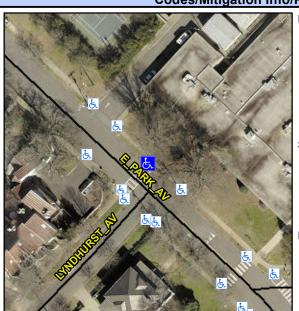
PROW/ADA:
Not Found, R304.5.1, R304.5.3

Compliance Description		Data	Comp	liance Description	Data
N/A	Ramp Length LT (in)	72.0	N/A	Ramp Length RT (in)	N/A
Yes	Ramp Width LT (in)	60.0	N/A	Ramp Width RT (in)	N/A
Yes	Ramp Slope LT (%)	5.8	N/A	Ramp Slope RT (%)	N/A
Yes	Ramp XSlope LT (%)	0.6	N/A	Ramp XSlope RT (%)	N/A
N/A	Ramp Length (in)	54.0	Yes	Ramp Slope (%)	4.6
No	Ramp Width (in)	47.0	No	Ramp XSlope (%)	6.0
N/A	Flare Type LT	N/A	N/A	Flare Type RT	N/A
N/A	Flare Slope LT (%)	N/A	N/A	Flare Slope RT (%)	N/A
N/A	Flare Traversable LT?	N/A	N/A	Flare Traversable RT?	N/A
N/A	Landing Length (in)	N/A	N/A	DWS Provided?	N/A
N/A	Landing Width (in)	N/A	N/A	DWS Contrast?	N/A
N/A	Landing Slope (%)	N/A	N/A	DWS Length (in)	N/A
N/A	Landing X Slope (%)	N/A	N/A	DWS Full Width?	N/A
N/A	Landing Curb? (Y/N)	N/A	N/A	DWS Offset (in)	N/A
N/A	Shared Landing?	N/A			
N/A	Gutter Ponding?	N/A	N/A	Gutter Slope (%)	N/A
N/A	Gutter Lip Ht (in)	N/A	N/A	Gutter X Slope (%)	N/A
N/A	Painted X Walk1?	Yes	N/A	Painted X Walk2?	N/A

Possible Solutions:
Remove & Replace Entire Ramp.

Total Cost: \$ 1600.00
