Access Compliance Report

Public Rights-of-Way

(Curb Ramps)

Intersection ID: 5855	Main Street: W_SUGAR_CREEK_RD	Cross Street: NEVIN_RD	Location:	E
ADA ID: 95D6DC9AB5E1	Ramp Type: Perp	Initial Pass/Fail: Pass	Overall Compliance: No	Severity Score: 5.25
Codes/Mitigation Info/Possible Solution		Field Measurements/Component Compliance

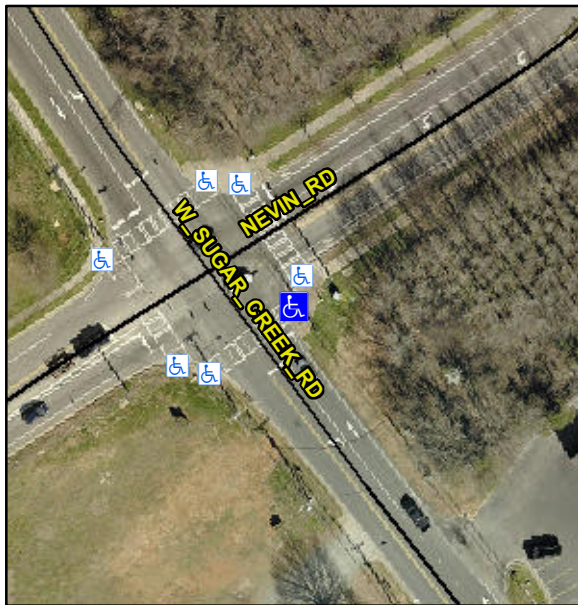
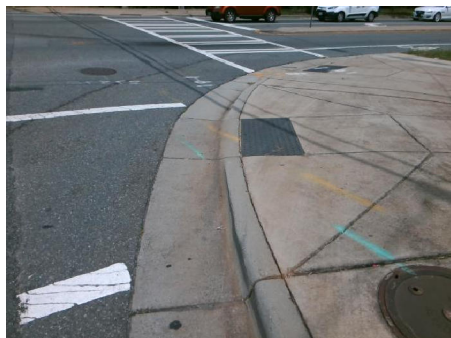
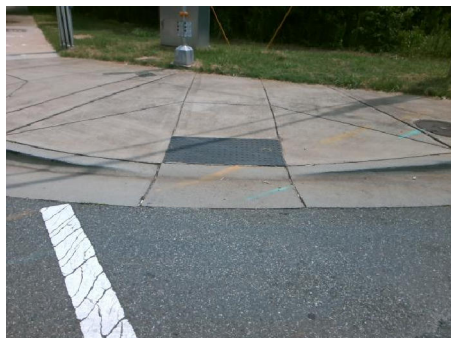
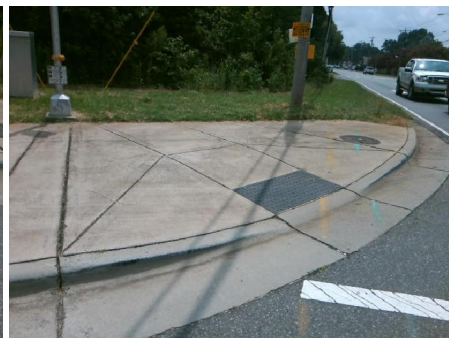
Not Found, R304.5.3, R304.5.4

Compliance	Description	Data	Compliance	Description	Data
N/A	Ramp Length (in)	72.5	Yes	Ramp Slope (%)	7.8
Yes	Ramp Width (in)	48.5	No	Ramp XSlope (%)	3.1
N/A	Flare Type LT	Sloped	N/A	Flare Type RT	N/A
N/A	Flare Slope LT (%)	1.5	N/A	Flare Slope RT (%)	10.3
N/A	Flare Traversable LT?	No	N/A	Flare Traversable RT?	No
Yes	Landing Length (in)	81.0	Yes	DWS Provided?	Yes
Yes	Landing Width (in)	48.5	Yes	DWS Contrast?	Yes
Yes	Landing Slope (%)	0.5	Yes	DWS Length (in)	24.0
No	Landing X Slope (%)	2.8	Yes	DWS Full Width?	Yes
N/A	Landing Curb? (Y/N)	No	Yes	DWS Offset (in)	1.5
N/A	Shared Landing?	No			
Yes	Gutter Ponding?	No	No	Gutter Slope (%)	6.1
Yes	Gutter Lip Ht (in)	0.0	No	Gutter X Slope (%)	2.6
N/A	Painted X Walk1?	Yes	N/A	Painted X Walk2?	N/A
	X Walk 1 Direction	To W		X Walk 2 Direction	N/A
N/A	X Walk 1 Width (in)	113.0	N/A	X Walk 2 Width (in)	N/A
	X Walk 1 Slope (%)	5.5		X Walk 2 Slope (%)	N/A
	X Walk 1 X Slope (%)	0.8		X Walk 2 X Slope (%)	N/A

Yes	Ramp inside XWalk1?	Yes	N/A	Ramp inside XWalk2?	N/A
	Road Slope (%)	N/A	N/A	Clear Space?	Yes
	Road X Slope (%)	N/A	N/A	Clear Space to XWalk (in)	N/A
Yes	Any Obstructions?	No	Yes	Storm Grate/Utility Hazard?	No
	Obstruction Type			Storm Grate/Utility Type	
			N/A		N/A
			Yes	Surface Condition? (G/P)	Good

Possible Solutions:

**Remove & Replace Entire Ramp.
Remove & Replace Gutter.**
