# Access Compliance Report

## Public Rights-of-Way

### (Curb Ramps)

Intersection ID: 45184	Main Street: HOLDEN_CT	Cross Street: TORRELLE_DR	Location: NE
ADA ID: 95DAA06BA52F	Ramp Type: BlendTrans1	Initial Pass/Fail: Fail	Overall Compliance: No
Severity Score: 8.75			
Codes/Mitigation Info/Possible Solution		Field Measurements/Component Compliance

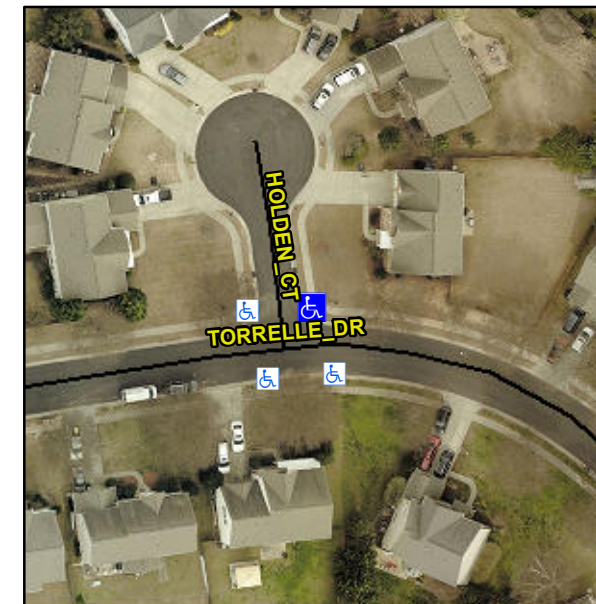
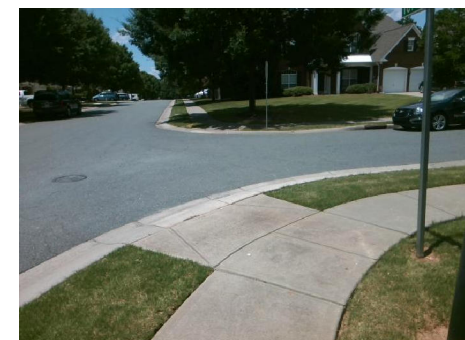
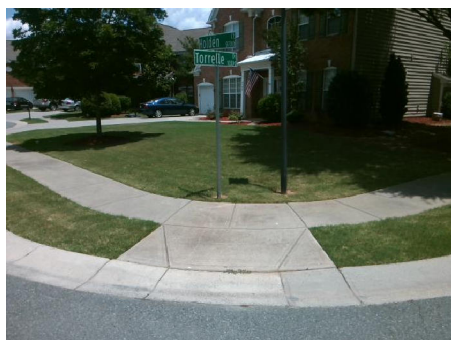
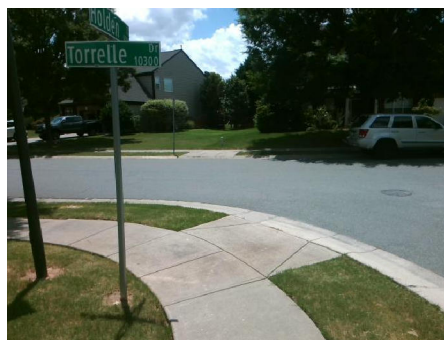
**Not Found, R304.5.1**

Compliance	Description	Data	Compliance	Description	Data
N/A	Ramp Length (in)	46.0	Yes	BlendTrans Slope (%)	1.3
No	Ramp Width (in)	46.0	Yes	BlendTrans XSlope (%)	0.1
N/A	Flare Type LT	N/A	N/A	Flare Type RT	N/A
N/A	Flare Slope LT (%)	N/A	N/A	Flare Slope RT (%)	N/A
N/A	Flare Traversable LT?	N/A	N/A	Flare Traversable RT?	N/A
N/A	Landing Length (in)	N/A	N/A	DWS Provided?	N/A
N/A	Landing Width (in)	N/A	N/A	DWS Contrast?	N/A
N/A	Landing Slope (%)	N/A	N/A	DWS Length (in)	N/A
N/A	Landing X Slope (%)	N/A	N/A	DWS Full Width?	N/A
N/A	Landing Curb? (Y/N)	N/A	N/A	DWS Offset (in)	N/A
N/A	Shared Landing?	N/A			
N/A	Gutter Ponding?	N/A	N/A	Gutter Slope (%)	N/A
N/A	Gutter Lip Ht (in)	N/A	N/A	Gutter X Slope (%)	N/A
N/A	Painted X Walk1?	No	N/A	Painted X Walk2?	No
	X Walk 1 Direction	To W		X Walk 2 Direction	To S
	X Walk 1 Width (in)	N/A		X Walk 2 Width (in)	N/A
	X Walk 1 Slope (%)	1.3		X Walk 2 Slope (%)	1.5
	X Walk 1 X Slope (%)	1.1		X Walk 2 X Slope (%)	1.7

N/A	Ramp inside XWalk1?	N/A	N/A	Ramp inside XWalk2?	N/A
	Road Slope (%)	1.0		Clear Space?	N/A
	Road X Slope (%)	1.2	N/A	Clear Space to XWalk (in)	N/A
N/A	Any Obstructions?	N/A	N/A	Storm Grate/Utility Hazard?	N/A
	Obstruction Type			Storm Grate/Utility Type	
		N/A			N/A
			Yes	Surface Condition? (G/P)	Good
			No	Curb Slope (%)	12.5

**Remove & Replace Curb Ramp With Two New Directional Ramps or Equivalent.**
