## **Access Compliance Report Public Rights-of-Way** (Curb Ramps)

Intersection ID: 10021903 Main Street: BROOKDALE AV **Cross Street: N/A** Location: Ε ADA ID: 95E8B844962B Ramp Type: PerpDiag Initial Pass/Fail: Fail **Overall Compliance: No Severity Score:** 10

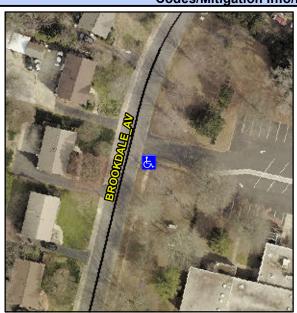
Compliance Description		Data	Compliance		Description	Data
N/A	Ramp Length (in)	76.0	Yes	Ramp Slope (%)		5.9
No	Ramp Width (in)	46.0	No	Ramp XSlope (%)		3.2
N/A	Flare Type LT	N/A	N/A	Flare	Type RT	N/A
N/A	Flare Slope LT (%)	N/A	N/A	Flare	Slope RT (%)	N/A
N/A	Flare Traversable LT?	N/A	N/A	Flare	Traversable RT?	N/A
N/A	Landing Length (in)	N/A	N/A	DWS	Provided?	N/A
N/A	Landing Width (in)	N/A	N/A	DWS	Contrast?	N/A
N/A	Landing Slope (%)	N/A	N/A	DWS	Length (in)	N/A
N/A	Landing X Slope (%)	N/A	N/A	DWS	Full Width?	N/A
N/A	Landing Curb? (Y/N)	N/A	N/A	DWS	Offset (in)	N/A
N/A	Shared Landing?	N/A				
N/A	Gutter Ponding?	N/A	N/A	Gutte	r Slope (%)	N/A
N/A	Gutter Lip Ht (in)	N/A	N/A	Gutte	r X Slope (%)	N/A
N/A	Painted X Walk1?	No	N/A	Paint	ed X Walk2?	No
	X Walk 1 Direction	To NE		X Wa	lk 2 Direction	To NW
N/A	X Walk 1 Width (in)	N/A	N/A	X Wa	lk 2 Width (in)	N/A
	X Walk 1 Slope (%)	0.4		X Wa	lk 2 Slope (%)	4.7
	X Walk 1 X Slope (%)	1.5		X Wa	lk 2 X Slope (%)	0.4

N/A	Ramp inside XWalk1?	N/A	N/A	Ram	inside XWalk2?	N/A
	Road Slope (%)	0.9	N/A	Clear	Space?	N/A
	Road X Slope (%)	1.9	N/A	Clear	Space to XWalk (in)	N/A
N/A	Any Obstructions?	N/A	N/A	Storn	n Grate/Utility Hazard?	N/A
	Obstruction Type			Storn	n Grate/Utility Type	
		N/A				N/A

Remove & Replace Curb Ramp With Two New Directional Ramps or Not Found, R304.5.1, R304.5.3

Total Cost: 3200.00
