# Access Compliance Report

## Public Rights-of-Way

### (Curb Ramps)

Intersection ID: 11994	Main Street: BELVEDERE_AV	Cross Street: THE_PLAZA	Location: NW
ADA ID: 95E978ABC65C	Ramp Type: Perp	Initial Pass/Fail: Fail	Overall Compliance: No
		Severity Score: 12.5

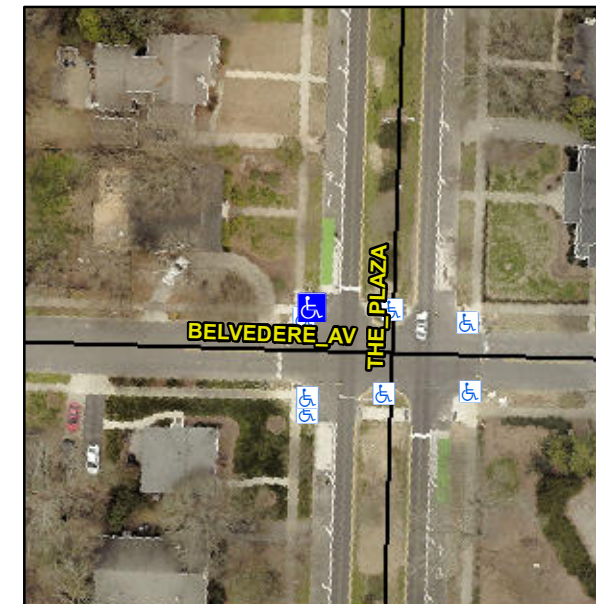
Compliance	Description	Data	Compliance	Description	Data
N/A	Ramp Length (in)	67.5	Yes	Ramp Slope (%)	6.1
Yes	Ramp Width (in)	65.5	No	Ramp XSlope (%)	5.8
N/A	Flare Type LT	N/A	N/A	Flare Type RT	N/A
N/A	Flare Slope LT (%)	N/A	N/A	Flare Slope RT (%)	N/A
N/A	Flare Traversable LT?	N/A	N/A	Flare Traversable RT?	N/A
N/A	Landing Length (in)	N/A	N/A	DWS Provided?	N/A
N/A	Landing Width (in)	N/A	N/A	DWS Contrast?	N/A
N/A	Landing Slope (%)	N/A	N/A	DWS Length (in)	N/A
N/A	Landing X Slope (%)	N/A	N/A	DWS Full Width?	N/A
N/A	Landing Curb? (Y/N)	N/A	N/A	DWS Offset (in)	N/A
N/A	Shared Landing?	N/A			
N/A	Gutter Ponding?	N/A	N/A	Gutter Slope (%)	N/A
N/A	Gutter Lip Ht (in)	N/A	N/A	Gutter X Slope (%)	N/A
N/A	Painted X Walk1?	Yes	N/A	Painted X Walk2?	N/A
	X Walk 1 Direction	To E		X Walk 2 Direction	N/A
N/A	X Walk 1 Width (in)	136.0	N/A	X Walk 2 Width (in)	N/A
	X Walk 1 Slope (%)	4.1		X Walk 2 Slope (%)	N/A
	X Walk 1 X Slope (%)	0.5		X Walk 2 X Slope (%)	N/A

N/A	Ramp inside XWalk1?	Yes	N/A	Ramp inside XWalk2?	N/A
	Road Slope (%)	N/A	N/A	Clear Space?	N/A
	Road X Slope (%)	N/A	N/A	Clear Space to XWalk (in)	N/A
N/A	Any Obstructions?	N/A	N/A	Storm Grate/Utility Hazard?	N/A
	Obstruction Type			Storm Grate/Utility Type	
		N/A			N/A
		Yes		Surface Condition? (G/P)	Good

**Remove & Replace Entire Ramp.**

**R304.5.3**

**\$ 1850.00**
