Access Compliance Report

Public Rights-of-Way

(Curb Ramps)

Intersection ID: 15786	Main Street: N_SHARON_AMITY_RD	Cross Street: AMITY_PL	Location: NE
ADA ID: 95EF8EA90B50	Ramp Type: Perp	Initial Pass/Fail: Fail	Overall Compliance: No
Severity Score: 21.25			
Codes/Mitigation Info/Possible Solution		Field Measurements/Component Compliance

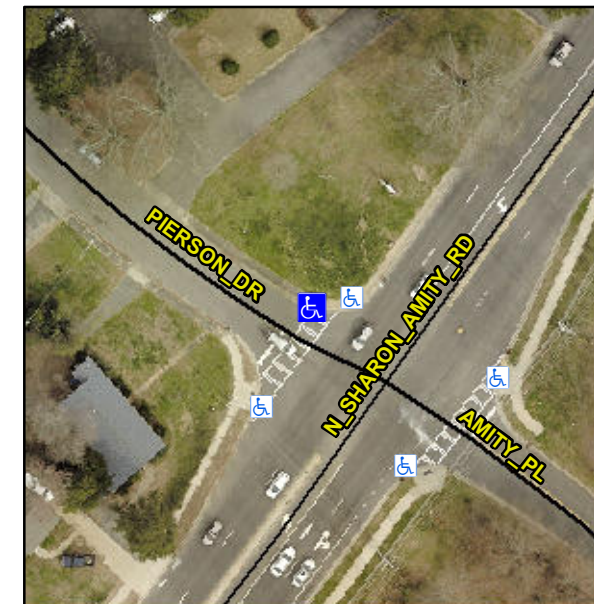
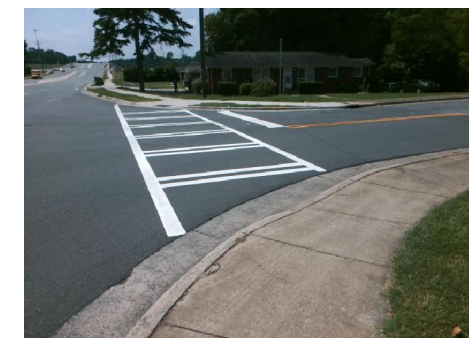
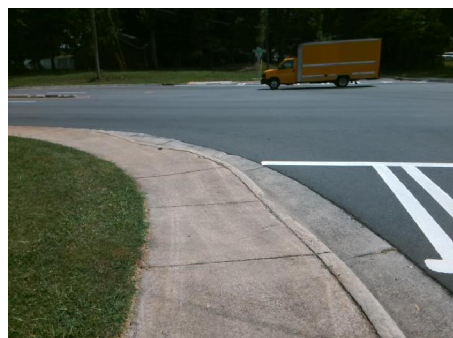
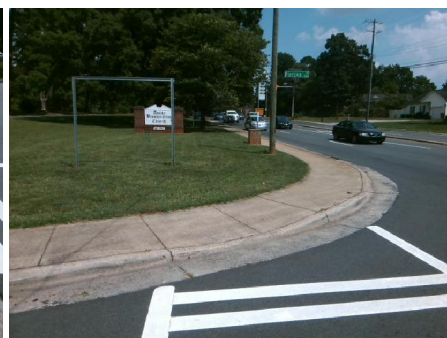
Not Found, R304.5.1, R304.2.2

Compliance	Description	Data	Compliance	Description	Data
N/A	Ramp Length (in)	59.0	No	Ramp Slope (%)	9.1
No	Ramp Width (in)	39.0	Yes	Ramp XSlope (%)	1.4
N/A	Flare Type LT	N/A	N/A	Flare Type RT	N/A
N/A	Flare Slope LT (%)	N/A	N/A	Flare Slope RT (%)	N/A
N/A	Flare Traversable LT?	N/A	N/A	Flare Traversable RT?	N/A
N/A	Landing Length (in)	N/A	N/A	DWS Provided?	N/A
N/A	Landing Width (in)	N/A	N/A	DWS Contrast?	N/A
N/A	Landing Slope (%)	N/A	N/A	DWS Length (in)	N/A
N/A	Landing X Slope (%)	N/A	N/A	DWS Full Width?	N/A
N/A	Landing Curb? (Y/N)	N/A	N/A	DWS Offset (in)	N/A
N/A	Shared Landing?	N/A			
N/A	Gutter Ponding?	N/A	N/A	Gutter Slope (%)	N/A
N/A	Gutter Lip Ht (in)	N/A	N/A	Gutter X Slope (%)	N/A
N/A	Painted X Walk1?	Yes	N/A	Painted X Walk2?	N/A
	X Walk 1 Direction	To SW		X Walk 2 Direction	N/A
N/A	X Walk 1 Width (in)	115.0	N/A	X Walk 2 Width (in)	N/A
	X Walk 1 Slope (%)	0.2		X Walk 2 Slope (%)	N/A
	X Walk 1 X Slope (%)	1.8		X Walk 2 X Slope (%)	N/A

N/A	Ramp inside XWalk1?	Yes	N/A	Ramp inside XWalk2?	N/A
	Road Slope (%)	N/A	N/A	Clear Space?	N/A
	Road X Slope (%)	N/A	N/A	Clear Space to XWalk (in)	N/A
N/A	Any Obstructions?	N/A	N/A	Storm Grate/Utility Hazard?	N/A
	Obstruction Type			Storm Grate/Utility Type	
		N/A			N/A
		Yes		Surface Condition? (G/P)	Good

Remove & Replace Entire Ramp.
