Access Compliance Report

Public Rights-of-Way

(Curb Ramps)

Intersection ID: 14495	Main Street: EASTWAY_DR	Cross Street: PINECREST_AV	Location: W
ADA ID: 95F1C63AADDB	Ramp Type: Para	Initial Pass/Fail: Fail	Overall Compliance: No
Codes/Mitigation Info/Possible Solution		Field Measurements/Component Compliance

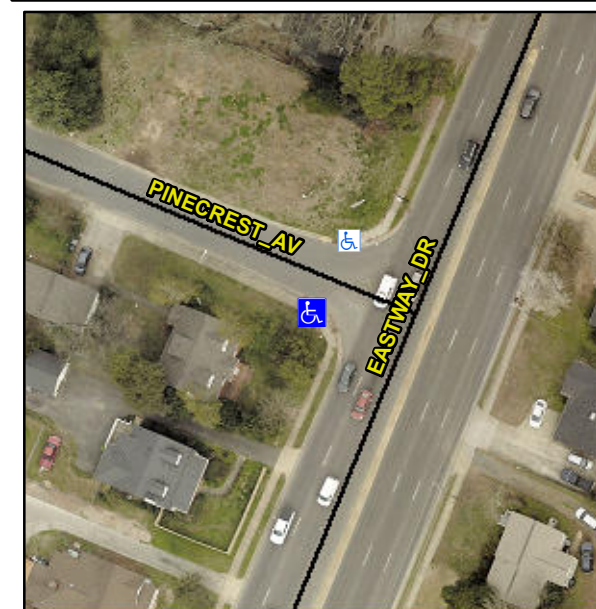
LT RP < 5%

R304.5.3, R304.3.2

Compliance	Description	Data	Compliance	Description	Data
N/A	Ramp Length LT (in)	51.0	N/A	Ramp Length RT (in)	64.0
Yes	Ramp Width LT (in)	72.0	Yes	Ramp Width RT (in)	72.0
Yes	Ramp Slope LT (%)	0.9	No	Ramp Slope RT (%)	8.4
No	Ramp XSlope LT (%)	2.2	Yes	Ramp XSlope RT (%)	2.0
N/A	Landing Length (in)	N/A	N/A	DWS Provided?	N/A
N/A	Landing Width (in)	N/A	N/A	DWS Contrast?	N/A
N/A	Landing Slope (%)	N/A	N/A	DWS Length (in)	N/A
N/A	Landing X Slope (%)	N/A	N/A	DWS Full Width?	N/A
N/A	Landing Curb? (Y/N)	N/A	N/A	DWS Offset (in)	N/A
N/A	Shared Landing?	N/A			
N/A	Gutter Ponding?	N/A	N/A	Gutter Slope (%)	N/A
N/A	Gutter Lip Ht (in)	N/A	N/A	Gutter X Slope (%)	N/A
N/A	Painted X Walk1?	No	N/A	Painted X Walk2?	N/A
	X Walk 1 Direction	To N		X Walk 2 Direction	N/A
N/A	X Walk 1 Width (in)	N/A	N/A	X Walk 2 Width (in)	N/A
	X Walk 1 Slope (%)	1.7		X Walk 2 Slope (%)	N/A
	X Walk 1 X Slope (%)	0.2		X Walk 2 X Slope (%)	N/A
N/A	Ramp inside XWalk1?	N/A	N/A	Ramp inside XWalk2?	N/A

Remove & Replace Entire Ramp.
