Access Compliance Report

Public Rights-of-Way

(Curb Ramps)

Intersection ID: 11933	Main Street: N_TRYON_ST	Cross Street: E_8TH_ST	Location: E
ADA ID: 95F1D444045B	Ramp Type: Perp	Initial Pass/Fail: Fail	Overall Compliance: No
Severity Score: 12.5			
Codes/Mitigation Info/Possible Solution		Field Measurements/Component Compliance

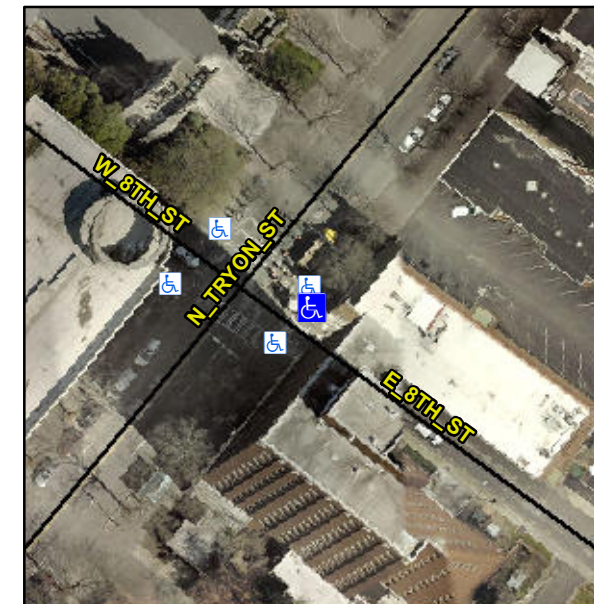
Compliance	Description	Data	Compliance	Description	Data
N/A	Ramp Length (in)	53.0	No	Ramp Slope (%)	8.9
Yes	Ramp Width (in)	48.0	Yes	Ramp XSlope (%)	1.8
N/A	Flare Type LT	N/A	N/A	Flare Type RT	N/A
N/A	Flare Slope LT (%)	N/A	N/A	Flare Slope RT (%)	N/A
N/A	Flare Traversable LT?	N/A	N/A	Flare Traversable RT?	N/A
N/A	Landing Length (in)	N/A	N/A	DWS Provided?	N/A
N/A	Landing Width (in)	N/A	N/A	DWS Contrast?	N/A
N/A	Landing Slope (%)	N/A	N/A	DWS Length (in)	N/A
N/A	Landing X Slope (%)	N/A	N/A	DWS Full Width?	N/A
N/A	Landing Curb? (Y/N)	N/A	N/A	DWS Offset (in)	N/A
N/A	Shared Landing?	N/A			
N/A	Gutter Ponding?	N/A	N/A	Gutter Slope (%)	N/A
N/A	Gutter Lip Ht (in)	N/A	N/A	Gutter X Slope (%)	N/A
N/A	Painted X Walk1?	Yes	N/A	Painted X Walk2?	N/A
	X Walk 1 Direction	To SW		X Walk 2 Direction	N/A
N/A	X Walk 1 Width (in)	110.0	N/A	X Walk 2 Width (in)	N/A
	X Walk 1 Slope (%)	3.0		X Walk 2 Slope (%)	N/A
	X Walk 1 X Slope (%)	6.1		X Walk 2 X Slope (%)	N/A

N/A	Ramp inside XWalk1?	Yes	N/A	Ramp inside XWalk2?	N/A
	Road Slope (%)	N/A	N/A	Clear Space?	N/A
	Road X Slope (%)	N/A	N/A	Clear Space to XWalk (in)	N/A
N/A	Any Obstructions?	N/A	N/A	Storm Grate/Utility Hazard?	N/A
	Obstruction Type			Storm Grate/Utility Type	
		N/A			N/A
		Yes		Surface Condition? (G/P)	Good

Possible Solutions:

Remove & Replace Entire Ramp.
