# Access Compliance Report

## Public Rights-of-Way (Curb Ramps)

Intersection ID: 27325	Main Street: TILLEY MORRIS RD	Cross Street: N/A	Location: N
ADA ID: 9602E4C9A29E	Ramp Type: Directional1	Initial Pass/Fail: Fail	Overall Compliance: No
		Severity Score: 1.25

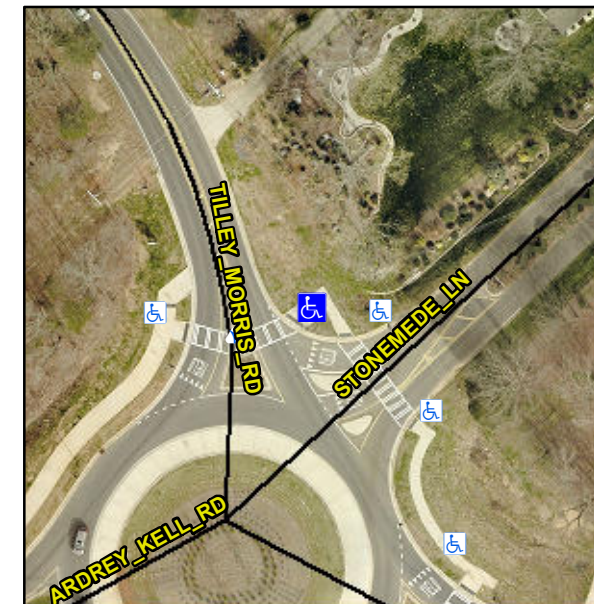
Compliance	Description	Data	Compliance	Description	Data
N/A	Ramp Length (in)	100.0	N/A	Grade Break?	N/A
Yes	Ramp Width (in)	135.0	N/A	Grade Break Slope (%)	0.0
Yes	Ramp Slope (%)	3.3	N/A	Grade Break XSlope (%)	0.0
No	Ramp XSlope (%)	3.4			
N/A	Flare Type LT	N/A	N/A	Flare Type RT	N/A
N/A	Flare Slope LT (%)	N/A	N/A	Flare Slope RT (%)	0.0
N/A	Flare Traversable LT?	N/A	N/A	Flare Traversable RT?	N/A
N/A	Landing Length (in)	0.0	N/A	DWS Provided?	N/A
N/A	Landing Width (in)	0.0	N/A	DWS Contrast?	N/A
N/A	Landing Slope (%)	0.0	N/A	DWS Length (in)	N/A
N/A	Landing X Slope (%)	0.0	N/A	DWS Full Width?	N/A
N/A	Landing Curb? (Y/N)	N/A	N/A	DWS Offset LT (in)	N/A
N/A	Shared Landing?	N/A	N/A	DWS Offset RT (in)	N/A
N/A	Gutter Ponding?	0.0	N/A	Gutter Slope (%)	N/A
N/A	Gutter Lip Ht (in)	0.0	N/A	Gutter X Slope (%)	N/A
N/A	Painted X Walk1?	Yes		Road Slope (%)	2.8
	X Walk 1 Direction	To W		Road X Slope (%)	1.5
	X Walk 1 Width (in)	112.0		Clear Space?	N/A

X Walk 1 Slope (%)	2.8	N/A	Clear Space to XWalk (in)	N/A
	X Walk 1 X Slope (%)	1.5	N/A	Storm Grate/Utility Hazard?	N/A
N/A	Ramp inside XWalk1?	Yes		Storm Grate/Utility Type	
N/A	Any Obstructions?	N/A			N/A
	Obstruction Type		Yes	Surface Condition? (G/P)	Good
			N/A	Curb Slope (%)	8.9

**Remove & Replace Entire Ramp.**

**R304.5.3**

\$ 1600.00
