Access Compliance Report

Public Rights-of-Way

(Curb Ramps)

Intersection ID: 27255	Main Street: BACK RIDGE RD	Cross Street: ROCK DOVE CT	Location: S
ADA ID: 96048949A109	Ramp Type: PerpDiag	Initial Pass/Fail: Fail	Overall Compliance: No
Severity Score: 72.5			
Codes/Mitigation Info/Possible Solution		Field Measurements/Component Compliance

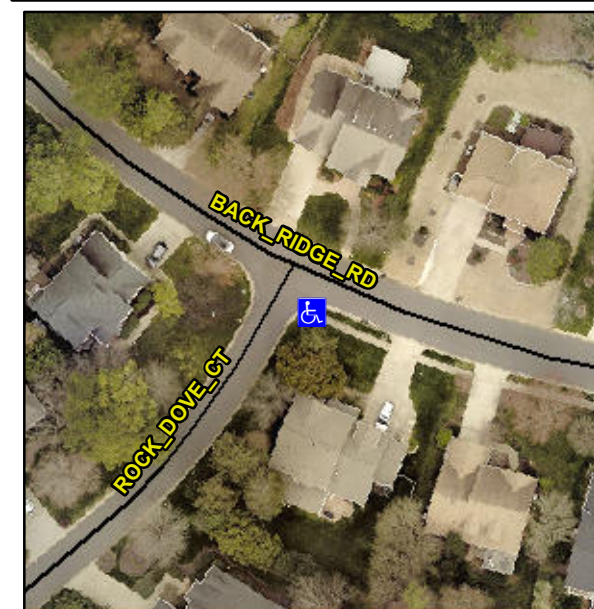
Not Found, R304.5.1, R304.2.2, R304.5.3

Compliance	Description	Data	Compliance	Description	Data
N/A	Ramp Length (in)	96.0	No	Ramp Slope (%)	11.9
No	Ramp Width (in)	30.0	No	Ramp XSlope (%)	11.7
N/A	Flare Type LT	N/A	N/A	Flare Type RT	N/A
N/A	Flare Slope LT (%)	N/A	N/A	Flare Slope RT (%)	N/A
N/A	Flare Traversable LT?	N/A	N/A	Flare Traversable RT?	N/A
N/A	Landing Length (in)	N/A	N/A	DWS Provided?	N/A
N/A	Landing Width (in)	N/A	N/A	DWS Contrast?	N/A
N/A	Landing Slope (%)	N/A	N/A	DWS Length (in)	N/A
N/A	Landing X Slope (%)	N/A	N/A	DWS Full Width?	N/A
N/A	Landing Curb? (Y/N)	N/A	N/A	DWS Offset (in)	N/A
N/A	Shared Landing?	N/A			
N/A	Gutter Ponding?	N/A	N/A	Gutter Slope (%)	N/A
N/A	Gutter Lip Ht (in)	N/A	N/A	Gutter X Slope (%)	N/A
N/A	Painted X Walk1?	No	N/A	Painted X Walk2?	No
	X Walk 1 Direction	To NE		X Walk 2 Direction	To NW
N/A	X Walk 1 Width (in)	N/A	N/A	X Walk 2 Width (in)	N/A
	X Walk 1 Slope (%)	3.9		X Walk 2 Slope (%)	4.0
	X Walk 1 X Slope (%)	5.1		X Walk 2 X Slope (%)	8.8

N/A	Ramp inside XWalk1?	N/A	N/A	Ramp inside XWalk2?	N/A
	Road Slope (%)	9.0	N/A	Clear Space?	N/A
	Road X Slope (%)	2.4	N/A	Clear Space to XWalk (in)	N/A
N/A	Any Obstructions?	N/A	N/A	Storm Grate/Utility Hazard?	N/A
	Obstruction Type			Storm Grate/Utility Type	
		N/A			N/A
			Yes	Surface Condition? (G/P)	Good

Possible Solutions:

Remove & Replace Curb Ramp With Two New Directional Ramps or Equivalent.
