## **Access Compliance Report Public Rights-of-Way** (Curb Ramps)

Intersection ID: 32102 Main Street: BLUE HERON DR Cross Street: CASTLE\_PINE\_CT Location: ADA ID: 9607FE9166D0 Ramp Type: Directional2 Initial Pass/Fail: Fail **Overall Compliance: No Severity Score:** 1.25

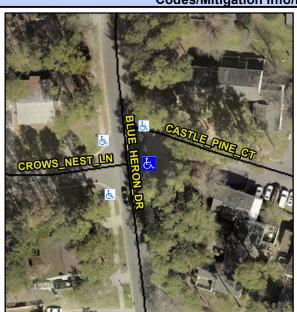
Field Measurements/Component Compliance						
Compliance Description		Data	Compliance		Description	Data
N/A	Ramp Length (in)	86.0	N/A	Grad	e Break?	N/A
Yes	Ramp Width (in)	50.0	N/A	Grad	e Break Slope (%)	0.0
Yes	Ramp Slope (%)	7.5	N/A	Grad	e Break XSlope (%)	0.0
No	Ramp XSlope (%)	4.7				
N/A	Flare Type LT	N/A	N/A	Flare	Type RT	N/A
N/A	Flare Slope LT (%)	N/A	N/A	Flare	Slope RT (%)	0.0
N/A	Flare Traversable LT?	N/A	N/A	Flare	Traversable RT?	N/A
N/A	Landing Length (in)	0.0	N/A	DWS	Provided?	N/A
N/A	Landing Width (in)	0.0	N/A	DWS	Contrast?	N/A
N/A	Landing Slope (%)	0.0	N/A	DWS	Length (in)	N/A
N/A	Landing X Slope (%)	0.0	N/A	DWS	Full Width?	N/A
N/A	Landing Curb? (Y/N)	N/A	N/A	DWS	Offset LT (in)	N/A
N/A	Shared Landing?	N/A	N/A	DWS	Offset RT (in)	N/A
N/A	Gutter Ponding?	0.0	N/A	Gutte	r Slope (%)	N/A
N/A	Gutter Lip Ht (in)	0.0	N/A	Gutte	er X Slope (%)	N/A
N/A	Painted X Walk1?	No		Road	Slope (%)	3.
	X Walk 1 Direction	To NW		Road	X Slope (%)	2.

X Walk 1 Width (in)	N/A		Clear	Space?	N/A
	X Walk 1 Slope (%)	3.4	N/A	Clear	Space to XWalk (in)	N/A
	X Walk 1 X Slope (%)	2.9	N/A	Storn	n Grate/Utility Hazard?	N/A
N/A	Ramp inside XWalk1?	N/A		Storn	n Grate/Utility Type	
N/A	Any Obstructions?	N/A				N/A
	Obstruction Type		Yes	Surfa	ce Condition? (G/P)	Good
		N/A	N/A	Curb	Slope (%)	8.

Possible Solutions: Remove & Replace Entire Ramp. Surveyor Notes: N/A PROW/ADA: R304.5.3
