Access Compliance Report

Public Rights-of-Way

(Curb Ramps)

Intersection ID: 2601	Main Street: PROSPERITY_CHURCH_RD	Cross Street: EASTFIELD_RD	Location:	N
ADA ID: 960F5C449061	Ramp Type: Perp	Initial Pass/Fail: Pass	Overall Compliance: No	Severity Score: 5.25
Codes/Mitigation Info/Possible Solution		Field Measurements/Component Compliance

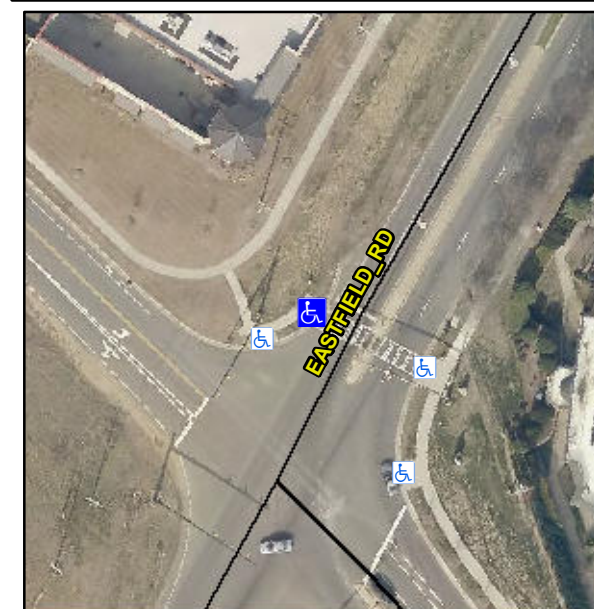
Compliance	Description	Data	Compliance	Description	Data
N/A	Ramp Length (in)	60.0	Yes	Ramp Slope (%)	7.2
Yes	Ramp Width (in)	48.0	No	Ramp XSlope (%)	2.3
N/A	Flare Type LT	Sloped	N/A	Flare Type RT	N/A
N/A	Flare Slope LT (%)	8.9	N/A	Flare Slope RT (%)	7.5
N/A	Flare Traversable LT?	Yes	N/A	Flare Traversable RT?	No
Yes	Landing Length (in)	60.0	Yes	DWS Provided?	Yes
Yes	Landing Width (in)	48.0	Yes	DWS Contrast?	Yes
Yes	Landing Slope (%)	1.9	Yes	DWS Length (in)	24.0
No	Landing X Slope (%)	2.2	Yes	DWS Full Width?	Yes
N/A	Landing Curb? (Y/N)	No	Yes	DWS Offset (in)	1.5
N/A	Shared Landing?	No			
Yes	Gutter Ponding?	No	No	Gutter Slope (%)	5.3
Yes	Gutter Lip Ht (in)	0.0	Yes	Gutter X Slope (%)	1.1
N/A	Painted X Walk1?	Yes	N/A	Painted X Walk2?	N/A
	X Walk 1 Direction	To SE		X Walk 2 Direction	N/A
N/A	X Walk 1 Width (in)	114.0	N/A	X Walk 2 Width (in)	N/A
	X Walk 1 Slope (%)	2.6		X Walk 2 Slope (%)	N/A
	X Walk 1 X Slope (%)	1.8		X Walk 2 X Slope (%)	N/A

Yes	Ramp inside XWalk1?	Yes	N/A	Ramp inside XWalk2?	N/A
	Road Slope (%)	N/A	N/A	Clear Space?	Yes
	Road X Slope (%)	N/A	N/A	Clear Space to XWalk (in)	N/A
Yes	Any Obstructions?	No	Yes	Storm Grate/Utility Hazard?	No
	Obstruction Type			Storm Grate/Utility Type	
		N/A			N/A
			Yes	Surface Condition? (G/P)	Good

Possible Solutions:

**Remove & Replace Entire Ramp.
Remove & Replace Gutter.**

R304.5.3, R304.5.4
