Access Compliance Report

Public Rights-of-Way

(Curb Ramps)

Intersection ID: 13227	Main Street: SUNNYSIDE_AV	Cross Street: LAMAR_AV	Location: NW
ADA ID: 9614F1239D23	Ramp Type: Perp	Initial Pass/Fail: Fail	Overall Compliance: No
Severity Score: 13.75			
Codes/Mitigation Info/Possible Solution		Field Measurements/Component Compliance

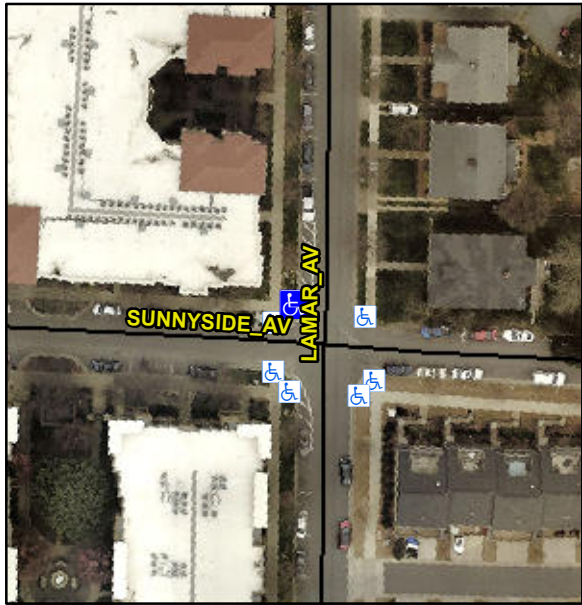
Compliance	Description	Data	Compliance	Description	Data
N/A	Ramp Length (in)	24.0	No	Ramp Slope (%)	10.1
Yes	Ramp Width (in)	73.0	No	Ramp XSlope (%)	4.0
N/A	Flare Type LT	N/A	N/A	Flare Type RT	N/A
N/A	Flare Slope LT (%)	N/A	N/A	Flare Slope RT (%)	N/A
N/A	Flare Traversable LT?	N/A	N/A	Flare Traversable RT?	N/A
N/A	Landing Length (in)	N/A	N/A	DWS Provided?	N/A
N/A	Landing Width (in)	N/A	N/A	DWS Contrast?	N/A
N/A	Landing Slope (%)	N/A	N/A	DWS Length (in)	N/A
N/A	Landing X Slope (%)	N/A	N/A	DWS Full Width?	N/A
N/A	Landing Curb? (Y/N)	N/A	N/A	DWS Offset (in)	N/A
N/A	Shared Landing?	N/A			
N/A	Gutter Ponding?	N/A	N/A	Gutter Slope (%)	N/A
N/A	Gutter Lip Ht (in)	N/A	N/A	Gutter X Slope (%)	N/A
N/A	Painted X Walk1?	No	N/A	Painted X Walk2?	N/A
	X Walk 1 Direction	To E		X Walk 2 Direction	N/A
N/A	X Walk 1 Width (in)	N/A	N/A	X Walk 2 Width (in)	N/A
	X Walk 1 Slope (%)	4.9		X Walk 2 Slope (%)	N/A
	X Walk 1 X Slope (%)	3.8		X Walk 2 X Slope (%)	N/A

N/A	Ramp inside XWalk1?	N/A	N/A	Ramp inside XWalk2?	N/A
	Road Slope (%)	N/A	N/A	Clear Space?	N/A
	Road X Slope (%)	N/A	N/A	Clear Space to XWalk (in)	N/A
N/A	Any Obstructions?	N/A	N/A	Storm Grate/Utility Hazard?	N/A
	Obstruction Type			Storm Grate/Utility Type	
		N/A			N/A
			Yes	Surface Condition? (G/P)	Good

Possible Solutions:						
	Remove & Replace Entire Ramp.						
	Surveyor Notes:						
		N/A					
	PROW/ADA:						
		Not Found, R304.2.2, R304.5.3					
Street 1 Name		LAMAR AV					
Stop Condition-Street 2		None					
Street 2 Name		N/A					
Stop Condition-Street 1		N/A					
Total Cost:		\$		1850.00
