# Access Compliance Report

## Public Rights-of-Way

Intersection ID: 12160	Main Street: E_9TH_ST	Cross Street: N_BREVARD_ST	Location: E
ADA ID: 961B1347BE45	Ramp Type: PerpDiag	Initial Pass/Fail: Fail	Overall Compliance: No
		Severity Score: 25

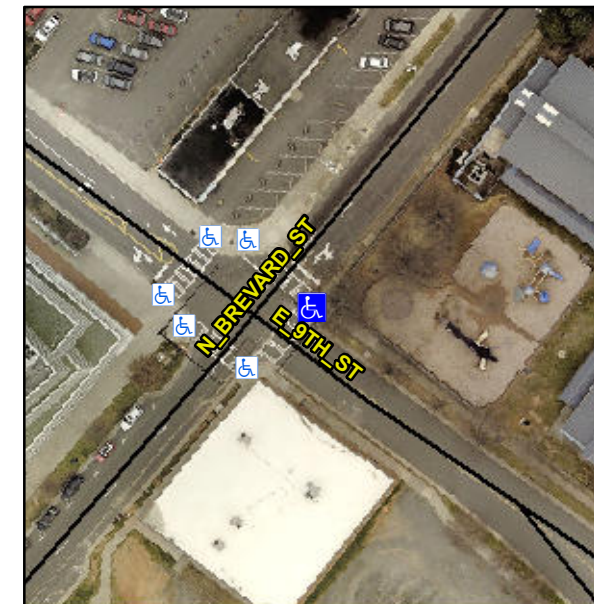
**Not Found, R304.2.2, R304.5.3**

Compliance	Description	Data	Compliance	Description	Data
N/A	Ramp Length (in)	48.0	No	Ramp Slope (%)	10.6
Yes	Ramp Width (in)	62.0	No	Ramp XSlope (%)	6.6
N/A	Flare Type LT	N/A	N/A	Flare Type RT	N/A
N/A	Flare Slope LT (%)	N/A	N/A	Flare Slope RT (%)	N/A
N/A	Flare Traversable LT?	N/A	N/A	Flare Traversable RT?	N/A
N/A	Landing Length (in)	N/A	N/A	DWS Provided?	N/A
N/A	Landing Width (in)	N/A	N/A	DWS Contrast?	N/A
N/A	Landing Slope (%)	N/A	N/A	DWS Length (in)	N/A
N/A	Landing X Slope (%)	N/A	N/A	DWS Full Width?	N/A
N/A	Landing Curb? (Y/N)	N/A	N/A	DWS Offset (in)	N/A
N/A	Shared Landing?	N/A			
N/A	Gutter Ponding?	N/A	N/A	Gutter Slope (%)	N/A
N/A	Gutter Lip Ht (in)	N/A	N/A	Gutter X Slope (%)	N/A
N/A	Painted X Walk1?	Yes	N/A	Painted X Walk2?	Yes
	X Walk 1 Direction	To NW		X Walk 2 Direction	To SW
N/A	X Walk 1 Width (in)	109.0	N/A	X Walk 2 Width (in)	111.0
	X Walk 1 Slope (%)	3.1		X Walk 2 Slope (%)	0.7
	X Walk 1 X Slope (%)	5.1		X Walk 2 X Slope (%)	4.0

N/A	Ramp inside XWalk1?	Yes	N/A	Ramp inside XWalk2?	Yes
	Road Slope (%)	5.3	N/A	Clear Space?	N/A
	Road X Slope (%)	2.1	N/A	Clear Space to XWalk (in)	N/A
N/A	Any Obstructions?	N/A	N/A	Storm Grate/Utility Hazard?	N/A
	Obstruction Type			Storm Grate/Utility Type	
		N/A			N/A
		Yes		Surface Condition? (G/P)	Good

**Remove & Replace Curb Ramp With Two New Directional Ramps or Equivalent.**

Total Cost: \$ 3200.00
