Access Compliance Report

Public Rights-of-Way

(Curb Ramps)

Intersection ID: 31906	Main Street: LAMOILLE_LN	Cross Street: PALOMAR_MOUNTAIN_DR	Location: SE
ADA ID: 962A8A99F7EA	Ramp Type: PerpDiag	Initial Pass/Fail: Fail	Overall Compliance: No
		Severity Score: 8.75

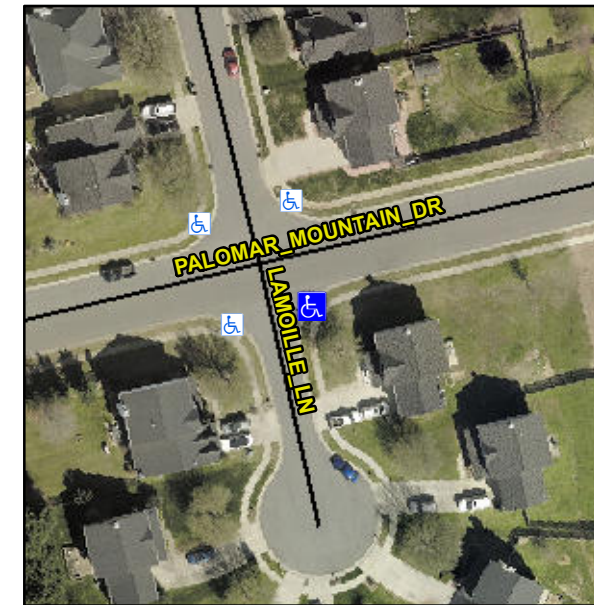
Compliance	Description	Data	Compliance	Description	Data
N/A	Ramp Length (in)	48.0	Yes	Ramp Slope (%)	5.3
No	Ramp Width (in)	46.0	Yes	Ramp XSlope (%)	2.0
N/A	Flare Type LT	N/A	N/A	Flare Type RT	N/A
N/A	Flare Slope LT (%)	N/A	N/A	Flare Slope RT (%)	N/A
N/A	Flare Traversable LT?	N/A	N/A	Flare Traversable RT?	N/A
N/A	Landing Length (in)	N/A	N/A	DWS Provided?	N/A
N/A	Landing Width (in)	N/A	N/A	DWS Contrast?	N/A
N/A	Landing Slope (%)	N/A	N/A	DWS Length (in)	N/A
N/A	Landing X Slope (%)	N/A	N/A	DWS Full Width?	N/A
N/A	Landing Curb? (Y/N)	N/A	N/A	DWS Offset (in)	N/A
N/A	Shared Landing?	N/A			
N/A	Gutter Ponding?	N/A	N/A	Gutter Slope (%)	N/A
N/A	Gutter Lip Ht (in)	N/A	N/A	Gutter X Slope (%)	N/A
N/A	Painted X Walk1?	No	N/A	Painted X Walk2?	No
	X Walk 1 Direction	To N		X Walk 2 Direction	To W
N/A	X Walk 1 Width (in)	N/A	N/A	X Walk 2 Width (in)	N/A
	X Walk 1 Slope (%)	1.0		X Walk 2 Slope (%)	0.8
	X Walk 1 X Slope (%)	1.2		X Walk 2 X Slope (%)	0.2

N/A	Ramp inside XWalk1?	N/A	N/A	Ramp inside XWalk2?	N/A
	Road Slope (%)	1.6	N/A	Clear Space?	N/A
	Road X Slope (%)	0.4	N/A	Clear Space to XWalk (in)	N/A
N/A	Any Obstructions?	N/A	N/A	Storm Grate/Utility Hazard?	N/A
	Obstruction Type			Storm Grate/Utility Type	
		N/A			N/A
			Yes	Surface Condition? (G/P)	Good

Remove & Replace Curb Ramp With Two New Directional Ramps or Equivalent.

R304.5.1
