Access Compliance Report

Public Rights-of-Way

(Curb Ramps)

Intersection ID: 11775	Main Street: E_18TH_ST	Cross Street: SEIGLE_AV	Location: W
ADA ID: 962B2B77988E	Ramp Type: Perp	Initial Pass/Fail: Fail	Overall Compliance: No
		Severity Score: 25

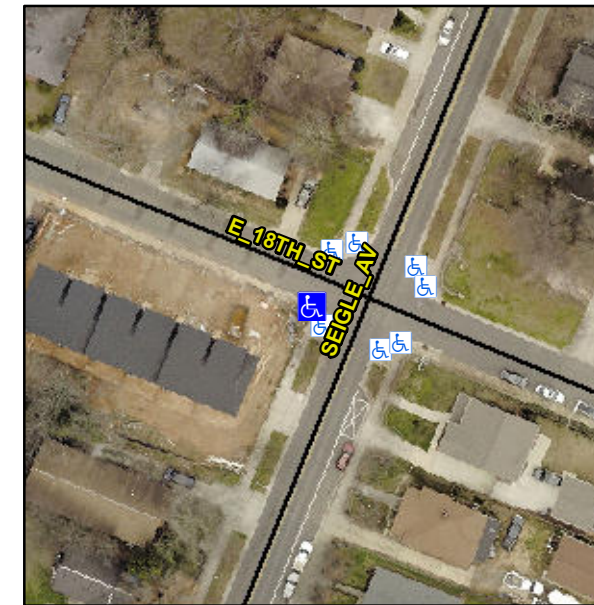
Not Found, R304.5.3

Compliance	Description	Data	Compliance	Description	Data
N/A	Ramp Length (in)	57.0	Yes	Ramp Slope (%)	5.0
Yes	Ramp Width (in)	50.0	No	Ramp XSlope (%)	8.4
N/A	Flare Type LT	N/A	N/A	Flare Type RT	N/A
N/A	Flare Slope LT (%)	N/A	N/A	Flare Slope RT (%)	N/A
N/A	Flare Traversable LT?	N/A	N/A	Flare Traversable RT?	N/A
N/A	Landing Length (in)	N/A	N/A	DWS Provided?	N/A
N/A	Landing Width (in)	N/A	N/A	DWS Contrast?	N/A
N/A	Landing Slope (%)	N/A	N/A	DWS Length (in)	N/A
N/A	Landing X Slope (%)	N/A	N/A	DWS Full Width?	N/A
N/A	Landing Curb? (Y/N)	N/A	N/A	DWS Offset (in)	N/A
N/A	Shared Landing?	N/A			
N/A	Gutter Ponding?	N/A	N/A	Gutter Slope (%)	N/A
N/A	Gutter Lip Ht (in)	0.75	N/A	Gutter X Slope (%)	N/A
N/A	Painted X Walk1?	No	N/A	Painted X Walk2?	N/A
	X Walk 1 Direction	To NE		X Walk 2 Direction	N/A
N/A	X Walk 1 Width (in)	N/A	N/A	X Walk 2 Width (in)	N/A
	X Walk 1 Slope (%)	2.2		X Walk 2 Slope (%)	N/A
	X Walk 1 X Slope (%)	8.4		X Walk 2 X Slope (%)	N/A

Remove & Replace Entire Ramp.
