Access Compliance Report

Public Rights-of-Way

(Curb Ramps)

Intersection ID: 14036	Main Street: COMMONWEALTH_AV	Cross Street: MORNINGSIDE_DR	Location: W
ADA ID: 9640D446D313	Ramp Type: Perp	Initial Pass/Fail: Fail	Overall Compliance: No
Codes/Mitigation Info/Possible Solution		Field Measurements/Component Compliance	
Severity Score: 33.75

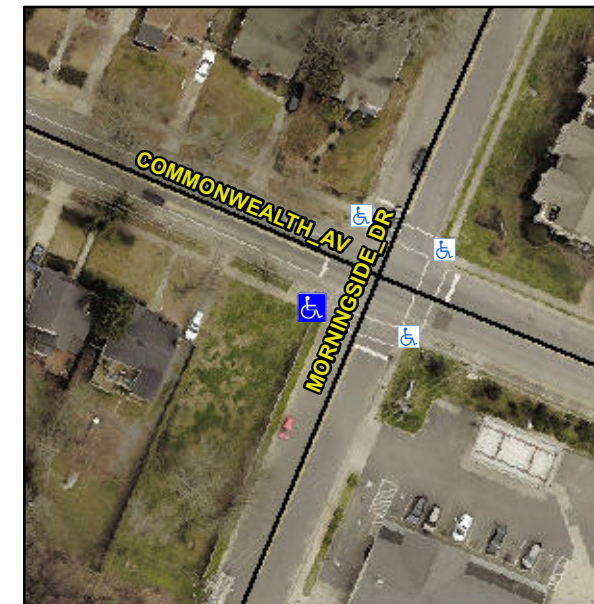
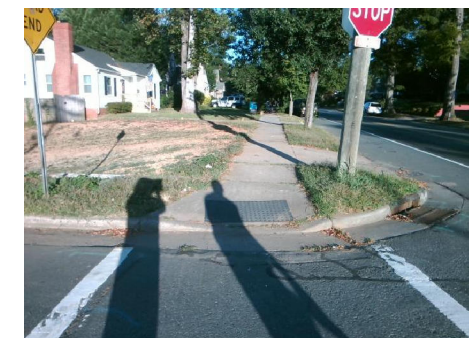
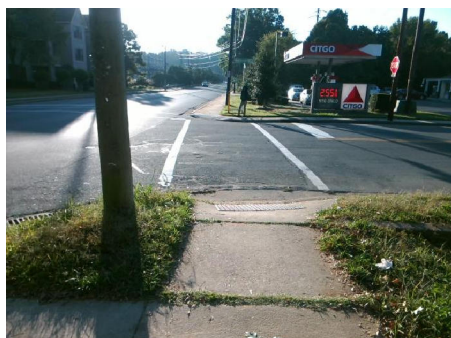
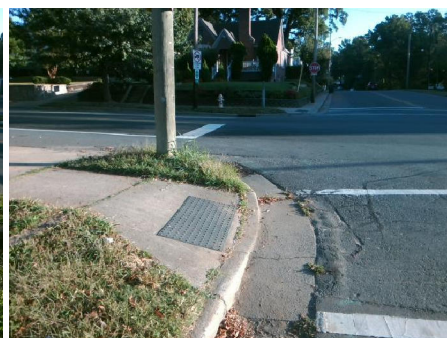
Not Found, R304.5.1, R304.2.2

Compliance	Description	Data	Compliance	Description	Data
N/A	Ramp Length (in)	54.0	No	Ramp Slope (%)	20.0
No	Ramp Width (in)	46.0	Yes	Ramp XSlope (%)	0.3
N/A	Flare Type LT	N/A	N/A	Flare Type RT	N/A
N/A	Flare Slope LT (%)	N/A	N/A	Flare Slope RT (%)	N/A
N/A	Flare Traversable LT?	N/A	N/A	Flare Traversable RT?	N/A
N/A	Landing Length (in)	N/A	N/A	DWS Provided?	N/A
N/A	Landing Width (in)	N/A	N/A	DWS Contrast?	N/A
N/A	Landing Slope (%)	N/A	N/A	DWS Length (in)	N/A
N/A	Landing X Slope (%)	N/A	N/A	DWS Full Width?	N/A
N/A	Landing Curb? (Y/N)	N/A	N/A	DWS Offset (in)	N/A
N/A	Shared Landing?	N/A			
N/A	Gutter Ponding?	N/A	N/A	Gutter Slope (%)	N/A
N/A	Gutter Lip Ht (in)	N/A	N/A	Gutter X Slope (%)	N/A
N/A	Painted X Walk1?	Yes	N/A	Painted X Walk2?	N/A
	X Walk 1 Direction	To SE		X Walk 2 Direction	N/A
N/A	X Walk 1 Width (in)	106.0	N/A	X Walk 2 Width (in)	N/A
	X Walk 1 Slope (%)	3.3		X Walk 2 Slope (%)	N/A
	X Walk 1 X Slope (%)	1.0		X Walk 2 X Slope (%)	N/A

N/A	Ramp inside XWalk1?	Yes	N/A	Ramp inside XWalk2?	N/A
	Road Slope (%)	N/A	N/A	Clear Space?	N/A
	Road X Slope (%)	N/A	N/A	Clear Space to XWalk (in)	N/A
N/A	Any Obstructions?	N/A	N/A	Storm Grate/Utility Hazard?	N/A
	Obstruction Type			Storm Grate/Utility Type	
		N/A			N/A
			Yes	Surface Condition? (G/P)	Good

Possible Solutions:

Remove & Replace Entire Ramp.
