Access Compliance Report

Public Rights-of-Way

(Curb Ramps)

Intersection ID: 28030	Main Street: CHEVIS_CT	Cross Street: LEGACY_CR	Location: SW
ADA ID: 964B0E5B9462	Ramp Type: BlendTrans1	Initial Pass/Fail: Fail	Overall Compliance: No
		Severity Score: 35

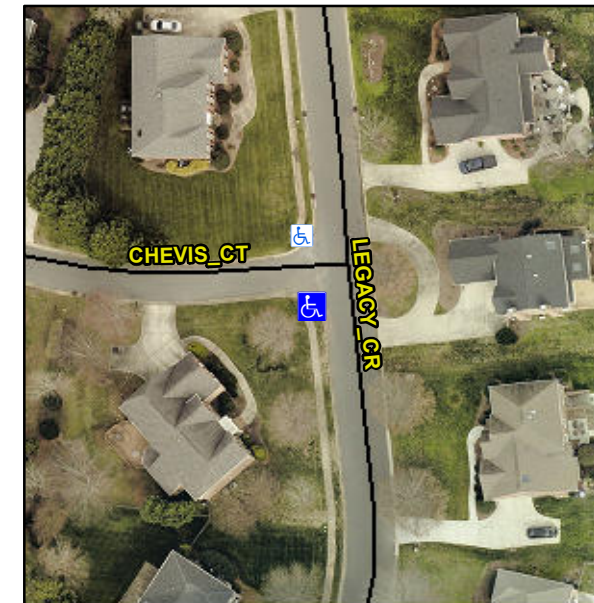
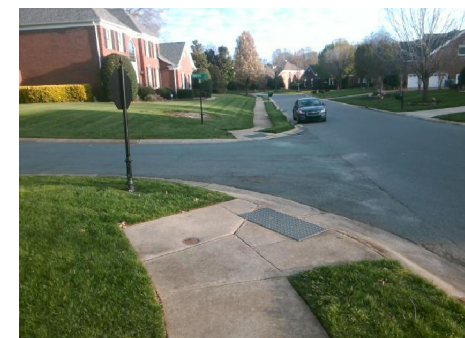
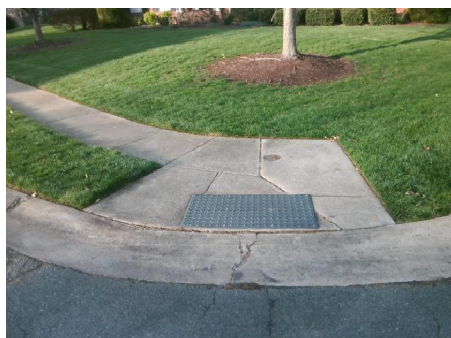
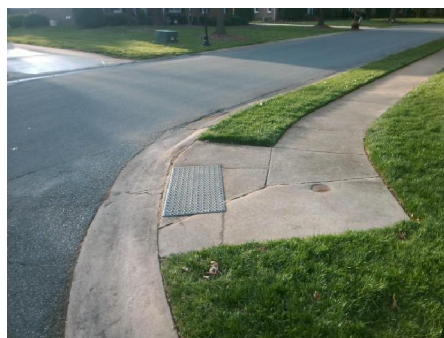
NO RT SW

Not Found, R304.5.1

Compliance	Description	Data	Compliance	Description	Data
N/A	Ramp Length (in)	46.0	Yes	BlendTrans Slope (%)	3.3
No	Ramp Width (in)	25.0	Yes	BlendTrans XSlope (%)	1.5
N/A	Flare Type LT	N/A	N/A	Flare Type RT	N/A
N/A	Flare Slope LT (%)	N/A	N/A	Flare Slope RT (%)	N/A
N/A	Flare Traversable LT?	N/A	N/A	Flare Traversable RT?	N/A
N/A	Landing Length (in)	N/A	N/A	DWS Provided?	N/A
N/A	Landing Width (in)	N/A	N/A	DWS Contrast?	N/A
N/A	Landing Slope (%)	N/A	N/A	DWS Length (in)	N/A
N/A	Landing X Slope (%)	N/A	N/A	DWS Full Width?	N/A
N/A	Landing Curb? (Y/N)	N/A	N/A	DWS Offset (in)	N/A
N/A	Shared Landing?	N/A			
N/A	Gutter Ponding?	N/A	N/A	Gutter Slope (%)	N/A
N/A	Gutter Lip Ht (in)	N/A	N/A	Gutter X Slope (%)	N/A
N/A	Painted X Walk1?	No	N/A	Painted X Walk2?	N/A
	X Walk 1 Direction	To N		X Walk 2 Direction	N/A
	X Walk 1 Width (in)	N/A		X Walk 2 Width (in)	N/A
	X Walk 1 Slope (%)	1.6		X Walk 2 Slope (%)	N/A
	X Walk 1 X Slope (%)	2.7		X Walk 2 X Slope (%)	N/A

N/A	Ramp inside XWalk1?	N/A	N/A	Ramp inside XWalk2?	N/A
	Road Slope (%)	2.7		Clear Space?	N/A
	Road X Slope (%)	1.6	N/A	Clear Space to XWalk (in)	N/A
N/A	Any Obstructions?	N/A	N/A	Storm Grate/Utility Hazard?	N/A
	Obstruction Type			Storm Grate/Utility Type	
		N/A			N/A
			Yes	Surface Condition? (G/P)	Good
			No	Curb Slope (%)	11.0

Remove & Replace Curb Ramp With Two New Directional Ramps or Equivalent.
