Access Compliance Report

Public Rights-of-Way

(Curb Ramps)

| Intersection ID: N/A | Main Street: ARROWOOD_RD | Cross Street: MICROSOFT_WY | Location: SW |

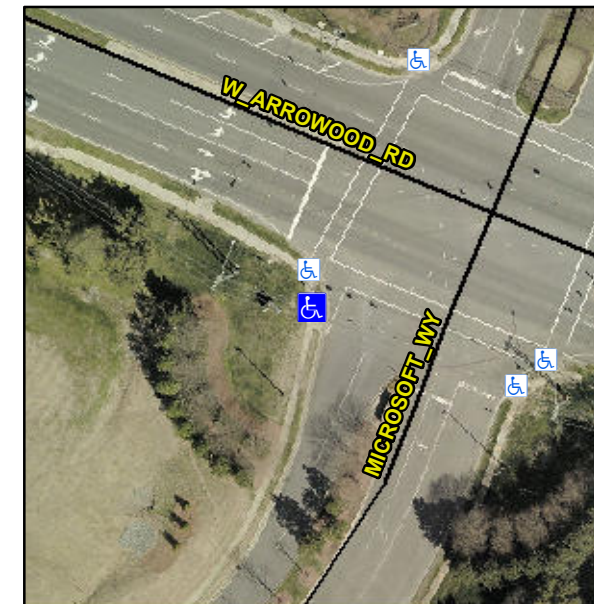
| ADA ID: 964D85EEB9A7 | Ramp Type: Perp | Initial Pass/Fail: Fail | Overall Compliance: No |
| | | Severity Score: 25 | |

| Compliance | Description | Data | Compliance | Description | Data |
|---|---|---|---|---|---|
| N/A | Ramp Length (in) | 95.0 | Yes | Ramp Slope (%) | 5.4 |
| Yes | Ramp Width (in) | 50.0 | No | Ramp XSlope (%) | 10.0 |
| N/A | Ramp inside XWalk1? | No | N/A | Ramp inside XWalk2? | N/A |

**Remove & Replace Entire Ramp.
Restripe Crosswalk.**

R304.5.3

Total Cost: \$ 2050.00
