# Access Compliance Report

## Public Rights-of-Way

### (Curb Ramps)

Intersection ID: 45861	Main Street: MADDOX_CT	Cross Street: HENDERSON_OAKS_DR	Location: W
ADA ID: 96536ED2F346	Ramp Type: Perp	Initial Pass/Fail: Fail	Overall Compliance: No
Severity Score: 26.25			
Codes/Mitigation Info/Possible Solution		Field Measurements/Component Compliance

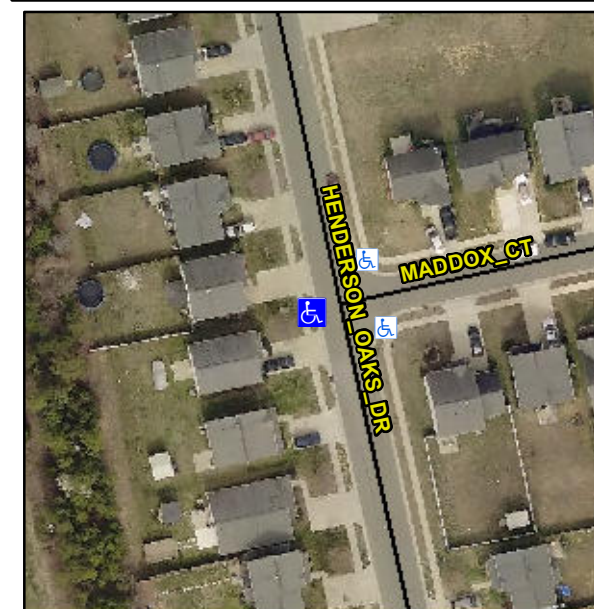
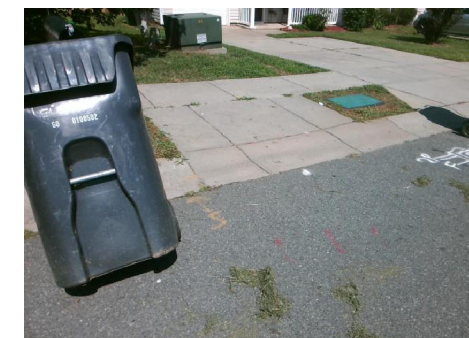
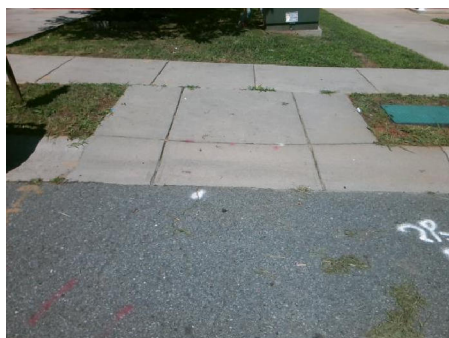
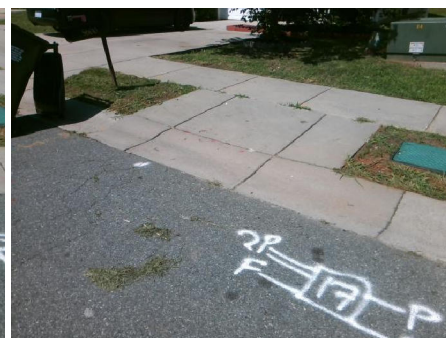
**Not Found, R304.2.2**

Compliance	Description	Data	Compliance	Description	Data
N/A	Ramp Length (in)	47.5	No	Ramp Slope (%)	16.3
Yes	Ramp Width (in)	48.0	Yes	Ramp XSlope (%)	3.2
N/A	Flare Type LT	N/A	N/A	Flare Type RT	N/A
N/A	Flare Slope LT (%)	N/A	N/A	Flare Slope RT (%)	N/A
N/A	Flare Traversable LT?	N/A	N/A	Flare Traversable RT?	N/A
N/A	Landing Length (in)	N/A	N/A	DWS Provided?	N/A
N/A	Landing Width (in)	N/A	N/A	DWS Contrast?	N/A
N/A	Landing Slope (%)	N/A	N/A	DWS Length (in)	N/A
N/A	Landing X Slope (%)	N/A	N/A	DWS Full Width?	N/A
N/A	Landing Curb? (Y/N)	N/A	N/A	DWS Offset (in)	N/A
N/A	Shared Landing?	N/A			
N/A	Gutter Ponding?	N/A	N/A	Gutter Slope (%)	N/A
N/A	Gutter Lip Ht (in)	N/A	N/A	Gutter X Slope (%)	N/A
N/A	Painted X Walk1?	No	N/A	Painted X Walk2?	N/A
	X Walk 1 Direction	To E		X Walk 2 Direction	N/A
N/A	X Walk 1 Width (in)	N/A	N/A	X Walk 2 Width (in)	N/A
	X Walk 1 Slope (%)	3.6		X Walk 2 Slope (%)	N/A
	X Walk 1 X Slope (%)	3.8		X Walk 2 X Slope (%)	N/A

N/A	Ramp inside XWalk1?	N/A	N/A	Ramp inside XWalk2?	N/A
	Road Slope (%)	N/A	N/A	Clear Space?	N/A
	Road X Slope (%)	N/A	N/A	Clear Space to XWalk (in)	N/A
N/A	Any Obstructions?	N/A	N/A	Storm Grate/Utility Hazard?	N/A
	Obstruction Type			Storm Grate/Utility Type	
		N/A			N/A
			Yes	Surface Condition? (G/P)	Good

**Remove & Replace Entire Ramp.**
