# Access Compliance Report

## Public Rights-of-Way

### (Curb Ramps)

Intersection ID: 11729	Main Street: CARLYLE_DR	Cross Street: WHITEHALL_DR	Location: NW
ADA ID: 9653BB07DD56	Ramp Type: Perp	Initial Pass/Fail: Fail	Overall Compliance: No
		Severity Score: 12.5

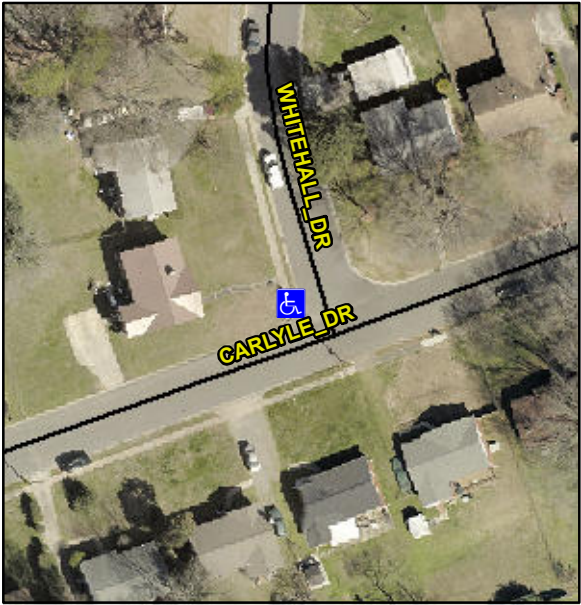
Possible Solutions:		<b>Compliance</b>	<b>Description</b>	<b>Data</b>
	<b>Remove &amp; Replace Entire Ramp.</b>		<b>No</b>	Ramp Length (in)	24.0
			<b>Yes</b>	Ramp Width (in)	48.0
			<b>N/A</b>	Flare Type LT	N/A
			<b>N/A</b>	Flare Slope LT (%)	N/A
			<b>N/A</b>	Flare Traversable LT?	N/A
			<b>N/A</b>	Landing Length (in)	N/A
			<b>N/A</b>	Landing Width (in)	N/A
			<b>N/A</b>	Landing Slope (%)	N/A
			<b>N/A</b>	Landing X Slope (%)	N/A
<p>Surveyor Notes:</p> <p><b>N/A</b></p> <p>PROW/ADA:</p> <p><b>Not Found, R304.2.2</b></p>			<b>N/A</b>	Flare Type RT	N/A
			<b>N/A</b>	Flare Slope RT (%)	N/A
			<b>N/A</b>	Flare Traversable RT?	N/A
			<b>N/A</b>	DWS Provided?	N/A
			<b>N/A</b>	DWS Contrast?	N/A
			<b>N/A</b>	DWS Length (in)	N/A
			<b>N/A</b>	DWS Full Width?	N/A
			<b>N/A</b>	DWS Offset (in)	N/A
			<b>N/A</b>	Shared Landing?	N/A

<b>N/A</b>	Gutter Ponding?	N/A
			<b>N/A</b>	Gutter Lip Ht (in)	N/A
			<b>No</b>	Painted X Walk1?	N/A
				X Walk 1 Direction	To E
			<b>N/A</b>	X Walk 1 Width (in)	N/A
				X Walk 1 Slope (%)	0.2
				X Walk 1 X Slope (%)	2.7
			<b>N/A</b>	Ramp inside XWalk1?	N/A
			<b>N/A</b>	Road Slope (%)	2.7
				Road X Slope (%)	0.2
			<b>N/A</b>	Any Obstructions?	N/A
				Obstruction Type	
Total Cost:					
		\$ 1850.00			
			<b>N/A</b>		<b>N/A</b>
			<b>Yes</b>	Surface Condition? (G/P)	<b>Good</b>
