Access Compliance Report

Public Rights-of-Way

(Curb Ramps)

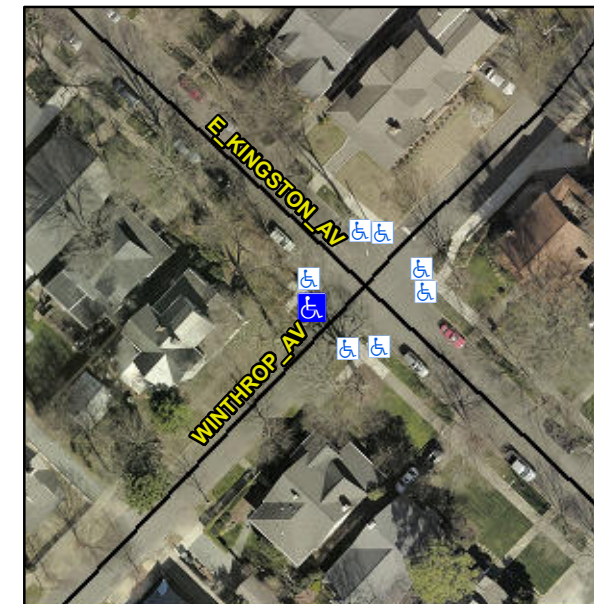
Intersection ID: 14366	Main Street: E_KINGSTON_AV	Cross Street: WINTHROP_AV	Location: W
ADA ID: 96548446FE71	Ramp Type: Directional1	Initial Pass/Fail: Fail	Overall Compliance: No
Severity Score: 22.5			
Codes/Mitigation Info/Possible Solution		Field Measurements/Component Compliance

R304.5.1, R304.2.2, R304.5.3

Compliance	Description	Data	Compliance	Description	Data
N/A	Ramp Length (in)	101.0	N/A	Grade Break?	N/A
No	Ramp Width (in)	36.0	N/A	Grade Break Slope (%)	0.0
No	Ramp Slope (%)	9.3	N/A	Grade Break XSlope (%)	0.0
No	Ramp XSlope (%)	3.0			
N/A	Flare Type LT	N/A	N/A	Flare Type RT	N/A
N/A	Flare Slope LT (%)	N/A	N/A	Flare Slope RT (%)	0.0
N/A	Flare Traversable LT?	N/A	N/A	Flare Traversable RT?	N/A
N/A	Landing Length (in)	0.0	N/A	DWS Provided?	N/A
N/A	Landing Width (in)	0.0	N/A	DWS Contrast?	N/A
N/A	Landing Slope (%)	0.0	N/A	DWS Length (in)	N/A
N/A	Landing X Slope (%)	0.0	N/A	DWS Full Width?	N/A
N/A	Landing Curb? (Y/N)	N/A	N/A	DWS Offset LT (in)	N/A
N/A	Shared Landing?	N/A	N/A	DWS Offset RT (in)	N/A
N/A	Gutter Ponding?	Yes	N/A	Gutter Slope (%)	N/A
N/A	Gutter Lip Ht (in)	0.0	N/A	Gutter X Slope (%)	N/A
N/A	Painted X Walk1?	No		Road Slope (%)	4.5
	X Walk 1 Direction	To SE		Road X Slope (%)	1.5
	X Walk 1 Width (in)	N/A		Clear Space?	N/A

X Walk 1 Slope (%)	4.5	N/A	Clear Space to XWalk (in)	N/A
	X Walk 1 X Slope (%)	1.5	N/A	Storm Grate/Utility Hazard?	N/A
N/A	Ramp inside XWalk1?	N/A		Storm Grate/Utility Type	
N/A	Any Obstructions?	N/A			N/A
	Obstruction Type		Yes	Surface Condition? (G/P)	Good
			N/A	Curb Slope (%)	4.0

Possible Solutions:

Remove & Replace Entire Ramp.
