Access Compliance Report Public Rights-of-Way (Curb Ramps)

Intersection ID: 31937 Main Street: CRANBORNE CHASE CT **Cross Street: STOKES AV** Location: SE ADA ID: 966856470C63 Ramp Type: PerpDiag Initial Pass/Fail: Fail **Overall Compliance: No Severity Score:** 30

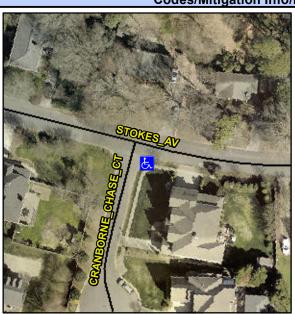
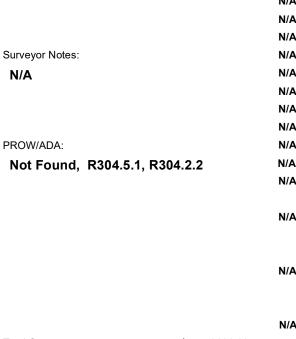
Not Found, R304.5.1, R304.2.2

Field Measurements/Component Compliance					
Compliance Description		Data	Comp	liance Description	Data
N/A	Ramp Length (in)	49.0	No	Ramp Slope (%)	9.0
No	Ramp Width (in)	32.0	Yes	Ramp XSlope (%)	0.7
N/A	Flare Type LT	N/A	N/A	Flare Type RT	N/A
N/A	Flare Slope LT (%)	N/A	N/A	Flare Slope RT (%)	N/A
N/A	Flare Traversable LT?	N/A	N/A	Flare Traversable RT?	N/A
N/A	Landing Length (in)	N/A	N/A	DWS Provided?	N/A
N/A	Landing Width (in)	N/A	N/A	DWS Contrast?	N/A
N/A	Landing Slope (%)	N/A	N/A	DWS Length (in)	N/A
N/A	Landing X Slope (%)	N/A	N/A	DWS Full Width?	N/A
N/A	Landing Curb? (Y/N)	N/A	N/A	DWS Offset (in)	N/A
N/A	Shared Landing?	N/A			
N/A	Gutter Ponding?	N/A	N/A	Gutter Slope (%)	N/A
N/A	Gutter Lip Ht (in)	N/A	N/A	Gutter X Slope (%)	N/A
N/A	Painted X Walk1?	No	N/A	Painted X Walk2?	No
	X Walk 1 Direction	To NE		X Walk 2 Direction	To NW
N/A	X Walk 1 Width (in)	N/A	N/A	X Walk 2 Width (in)	N/A
	X Walk 1 Slope (%)	2.4		X Walk 2 Slope (%)	1.5

Possible Solutions: Remove & Replace Curb Ramp With Two New Directional Ramps or Equivalent.
