Intersection ID: 12344	Main Street: REMOUNT_RD	Cross Street: GREENLAND_AV	Location:	SW
ADA ID: 966CB26532E2	Ramp Type: Perp	Initial Pass/Fail: Fail	Overall Compliance: No	Severity Score: 8.75

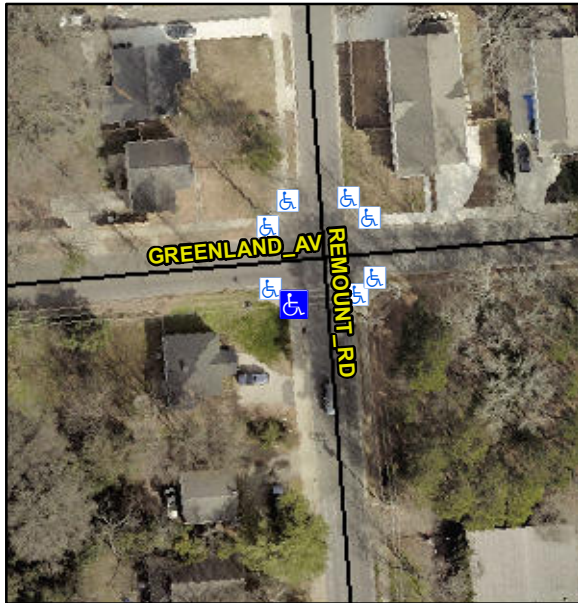
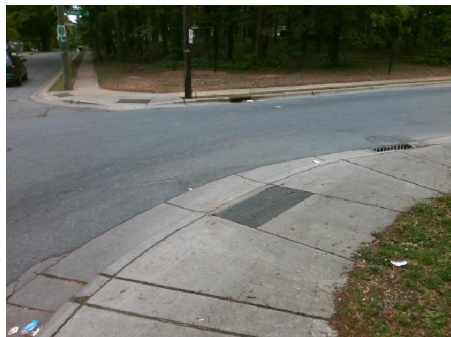
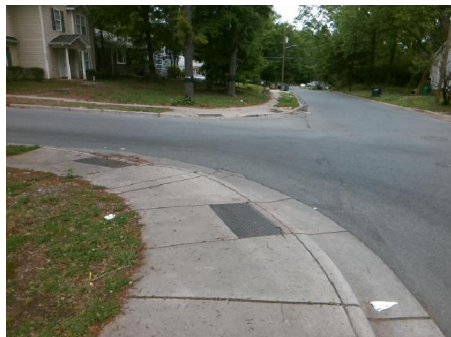
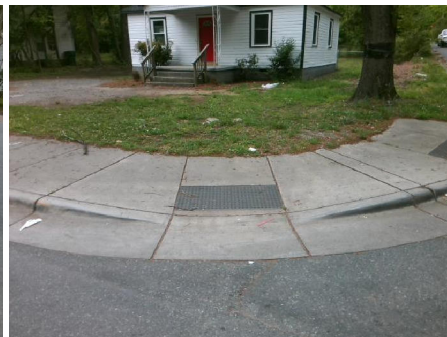
Not Found, R304.5.1

Possible Solutions:			Compliance	Description	Data	Compliance	Description	Data
Remove & Replace Entire Ramp.			N/A	Ramp Length (in)	73.5	Yes	Ramp Slope (%)	7.3
			No	Ramp Width (in)	47.0	Yes	Ramp XSlope (%)	0.9
			N/A	Flare Type LT	N/A	N/A	Flare Type RT	N/A
			N/A	Flare Slope LT (%)	N/A	N/A	Flare Slope RT (%)	N/A
			N/A	Flare Traversable LT?	N/A	N/A	Flare Traversable RT?	N/A
			N/A	Landing Length (in)	N/A	N/A	DWS Provided?	N/A
			N/A	Landing Width (in)	N/A	N/A	DWS Contrast?	N/A
			N/A	Landing Slope (%)	N/A	N/A	DWS Length (in)	N/A
			N/A	Landing X Slope (%)	N/A	N/A	DWS Full Width?	N/A
			N/A	Landing Curb? (Y/N)	N/A	N/A	DWS Offset (in)	N/A
Surveyor Notes: N/A			N/A	Shared Landing?	N/A			
			N/A	Gutter Ponding?	N/A	N/A	Gutter Slope (%)	N/A
			N/A	Gutter Lip Ht (in)	N/A	N/A	Gutter X Slope (%)	N/A
			N/A	Painted X Walk1?	No	N/A	Painted X Walk2?	N/A
				X Walk 1 Direction	To E		X Walk 2 Direction	N/A
			N/A	X Walk 1 Width (in)	N/A	N/A	X Walk 2 Width (in)	N/A

X Walk 1 Slope (%)	2.0		X Walk 2 Slope (%)	N/A
				X Walk 1 X Slope (%)	2.6		X Walk 2 X Slope (%)	N/A
			N/A	Ramp inside XWalk1?	N/A	N/A	Ramp inside XWalk2?	N/A
				Road Slope (%)	N/A	N/A	Clear Space?	N/A
PROW/ADA: Not Found, R304.5.1				Road X Slope (%)	N/A	N/A	Clear Space to XWalk (in)	N/A
			N/A	Any Obstructions?	N/A	N/A	Storm Grate/Utility Hazard?	N/A
				Obstruction Type			Storm Grate/Utility Type	
					N/A			N/A
						Yes	Surface Condition? (G/P)	Good
Total Cost:			\$	1850.00

Remove & Replace Entire Ramp.
