Access Compliance Report

Public Rights-of-Way

(Curb Ramps)

Intersection ID: 11958	Main Street: E_16TH_ST	Cross Street: SEIGLE_AV	Location: E
ADA ID: 967616DBA6E7	Ramp Type: Perp	Initial Pass/Fail: Fail	Overall Compliance: No
		Severity Score: 1.25

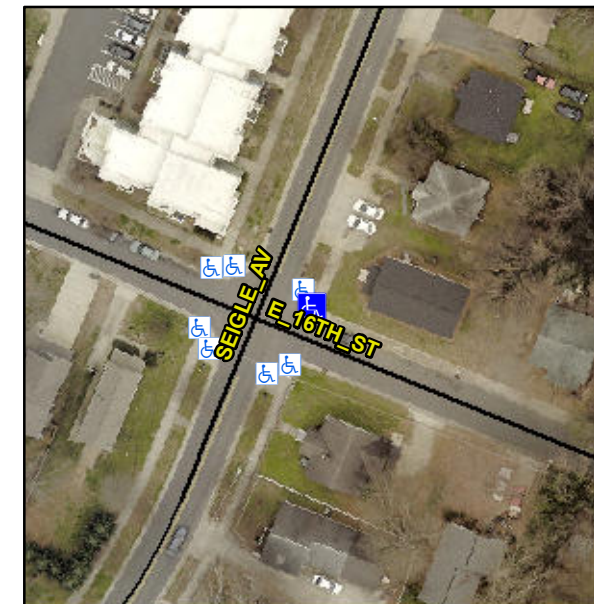
Not Found, R304.5.3

Compliance	Description	Data	Compliance	Description	Data
N/A	Ramp Length (in)	80.0	Yes	Ramp Slope (%)	5.4
Yes	Ramp Width (in)	95.0	No	Ramp XSlope (%)	2.6
N/A	Flare Type LT	N/A	N/A	Flare Type RT	N/A
N/A	Flare Slope LT (%)	N/A	N/A	Flare Slope RT (%)	N/A
N/A	Flare Traversable LT?	N/A	N/A	Flare Traversable RT?	N/A
N/A	Landing Length (in)	N/A	N/A	DWS Provided?	N/A
N/A	Landing Width (in)	N/A	N/A	DWS Contrast?	N/A
N/A	Landing Slope (%)	N/A	N/A	DWS Length (in)	N/A
N/A	Landing X Slope (%)	N/A	N/A	DWS Full Width?	N/A
N/A	Landing Curb? (Y/N)	N/A	N/A	DWS Offset (in)	N/A
N/A	Shared Landing?	N/A			
N/A	Gutter Ponding?	N/A	N/A	Gutter Slope (%)	N/A
N/A	Gutter Lip Ht (in)	N/A	N/A	Gutter X Slope (%)	N/A
N/A	Painted X Walk1?	No	N/A	Painted X Walk2?	N/A
	X Walk 1 Direction	To SW		X Walk 2 Direction	N/A
N/A	X Walk 1 Width (in)	N/A	N/A	X Walk 2 Width (in)	N/A
	X Walk 1 Slope (%)	2.3		X Walk 2 Slope (%)	N/A
	X Walk 1 X Slope (%)	3.2		X Walk 2 X Slope (%)	N/A

Remove & Replace Entire Ramp.
