Access Compliance Report

Public Rights-of-Way

(Curb Ramps)

Intersection ID: 23437	Main Street: TRYON_ST	Cross Street: MOSS_RD	Location: NW
ADA ID: 968087E1F215	Ramp Type: MedianPerp	Initial Pass/Fail: Fail	Overall Compliance: No
			Severity Score: 21.25

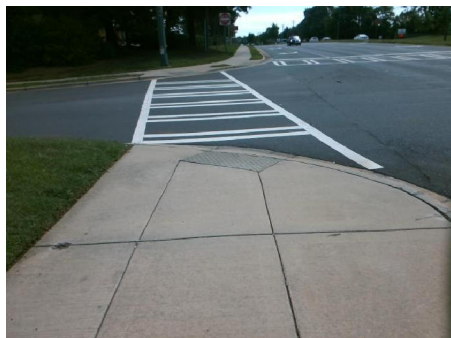
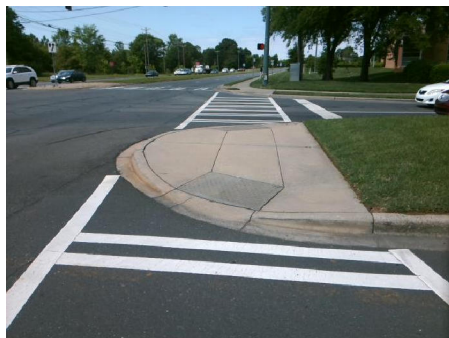
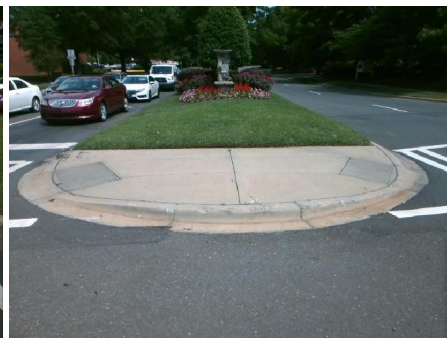
Not Found, R304.5.1, R304.2.2

Compliance	Description	Data	Compliance	Description	Data
N/A	Ramp Length (in)	46.0	No	Ramp Slope (%)	9.8
No	Ramp Width (in)	41.0	Yes	Ramp XSlope (%)	0.0
N/A	Flare Type LT	N/A	N/A	Flare Type RT	N/A
N/A	Flare Slope LT (%)	N/A	N/A	Flare Slope RT (%)	N/A
N/A	Flare Traversable LT?	N/A	N/A	Flare Traversable RT?	N/A
N/A	Landing Length (in)	N/A	N/A	DWS Provided?	N/A
N/A	Landing Width (in)	N/A	N/A	DWS Contrast?	N/A
N/A	Landing Slope (%)	N/A	N/A	DWS Length (in)	N/A
N/A	Landing X Slope (%)	N/A	N/A	DWS Full Width?	N/A
N/A	Landing Curb? (Y/N)	N/A	N/A	DWS Offset (in)	N/A
N/A	Shared Landing?	N/A			
N/A	Gutter Ponding?	N/A	N/A	Gutter Slope (%)	N/A
N/A	Gutter Lip Ht (in)	N/A	N/A	Gutter X Slope (%)	N/A
N/A	Painted X Walk1?	Yes	N/A	Painted X Walk2?	N/A
	X Walk 1 Direction	To E		X Walk 2 Direction	N/A
N/A	X Walk 1 Width (in)	115.0	N/A	X Walk 2 Width (in)	N/A
	X Walk 1 Slope (%)	3.2		X Walk 2 Slope (%)	N/A
	X Walk 1 X Slope (%)	3.4		X Walk 2 X Slope (%)	N/A

N/A	Ramp inside XWalk1?	Yes	N/A	Ramp inside XWalk2?	N/A
	Road Slope (%)	N/A	N/A	Clear Space?	N/A
	Road X Slope (%)	N/A	N/A	Clear Space to XWalk (in)	N/A
N/A	Any Obstructions?	N/A	N/A	Storm Grate/Utility Hazard?	N/A
	Obstruction Type			Storm Grate/Utility Type	
		N/A			N/A
			Yes	Surface Condition? (G/P)	Good

Remove & Replace Entire Ramp.
