# Access Compliance Report

## Public Rights-of-Way

### (Curb Ramps)

| Intersection ID: 44217 | Main Street: HENNIGAN_PLACE_LN | Cross Street: ROZZELLES_LANDING_DR | Location: NE |

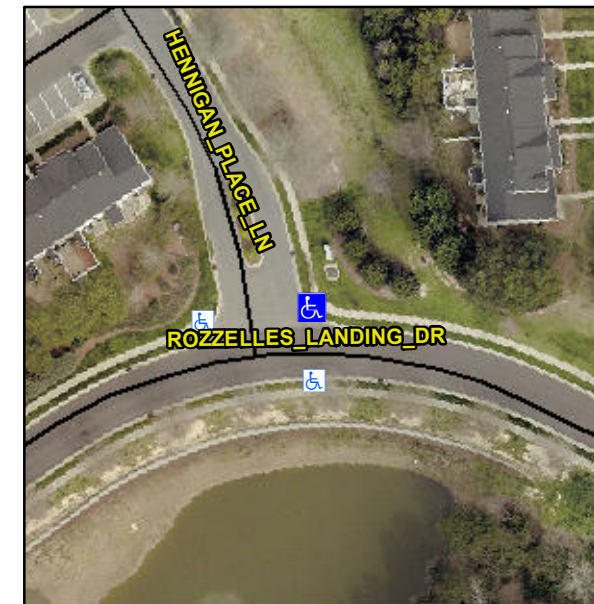
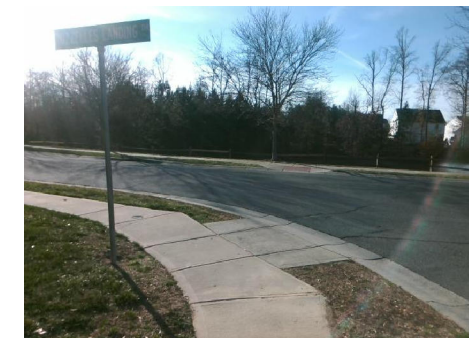
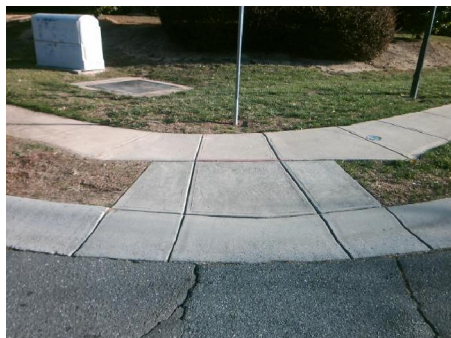
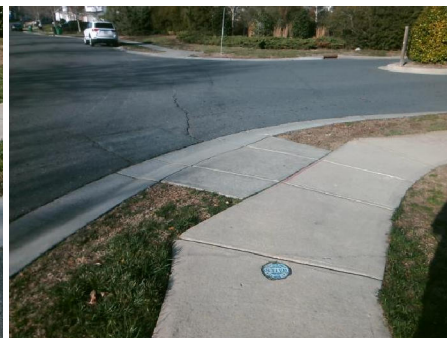
| ADA ID: 968122719B90 | Ramp Type: PerpDiag | Initial Pass/Fail: Fail | Overall Compliance: No |

| Severity Score: 10 | | | |

| Compliance | Description | Data | Compliance | Description | Data |
|---|---|---|---|---|---|
| N/A | Ramp Length (in) | 48.0 | Yes | Ramp Slope (%) | 5.7 |
| No | Ramp Width (in) | 39.5 | No | Ramp XSlope (%) | 3.8 |

**Remove & Replace Curb Ramp With Two New Directional Ramps or Equivalent.**

**R304.5.1, R304.5.3**

Total Cost: \$ 3200.00
