# Access Compliance Report

## Public Rights-of-Way

### (Curb Ramps)

Intersection ID: 10075	Main Street: BURNT_UMBER_DR	Cross Street: PLOTT_RD	Location:	N
ADA ID: 9684BECF7E97	Ramp Type: Perp	Initial Pass/Fail: Fail	Overall Compliance: No	Severity Score: 46.25
Codes/Mitigation Info/Possible Solution		Field Measurements/Component Compliance

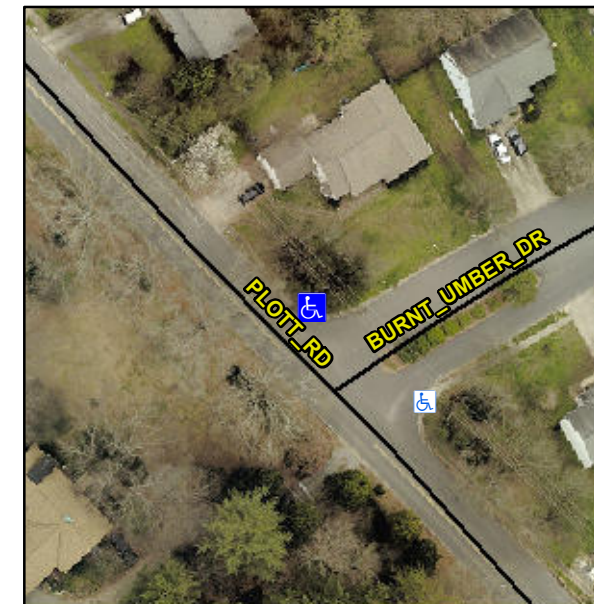
**Not Found, R304.5.1, R304.2.2, R304.5.3**

Compliance	Description	Data	Compliance	Description	Data
N/A	Ramp Length (in)	48.0	No	Ramp Slope (%)	19.0
No	Ramp Width (in)	43.0	No	Ramp XSlope (%)	5.2
N/A	Flare Type LT	N/A	N/A	Flare Type RT	N/A
N/A	Flare Slope LT (%)	N/A	N/A	Flare Slope RT (%)	N/A
N/A	Flare Traversable LT?	N/A	N/A	Flare Traversable RT?	N/A
N/A	Landing Length (in)	N/A	N/A	DWS Provided?	N/A
N/A	Landing Width (in)	N/A	N/A	DWS Contrast?	N/A
N/A	Landing Slope (%)	N/A	N/A	DWS Length (in)	N/A
N/A	Landing X Slope (%)	N/A	N/A	DWS Full Width?	N/A
N/A	Landing Curb? (Y/N)	N/A	N/A	DWS Offset (in)	N/A
N/A	Shared Landing?	N/A			
N/A	Gutter Ponding?	N/A	N/A	Gutter Slope (%)	N/A
N/A	Gutter Lip Ht (in)	N/A	N/A	Gutter X Slope (%)	N/A
N/A	Painted X Walk1?	No	N/A	Painted X Walk2?	N/A
	X Walk 1 Direction	To SE		X Walk 2 Direction	N/A
N/A	X Walk 1 Width (in)	N/A	N/A	X Walk 2 Width (in)	N/A
	X Walk 1 Slope (%)	1.0		X Walk 2 Slope (%)	N/A
	X Walk 1 X Slope (%)	4.0		X Walk 2 X Slope (%)	N/A

**Remove & Replace Entire Ramp.**
