# Access Compliance Report

## Public Rights-of-Way

### (Curb Ramps)

Intersection ID: 9172	Main Street: E_CRAIGHEAD_RD	Cross Street: N_TRYON_ST	Location:	NW
ADA ID: 968FF211DFBA	Ramp Type: Perp	Initial Pass/Fail: Fail	Overall Compliance: No	Severity Score: 8.75
Codes/Mitigation Info/Possible Solution		Field Measurements/Component Compliance

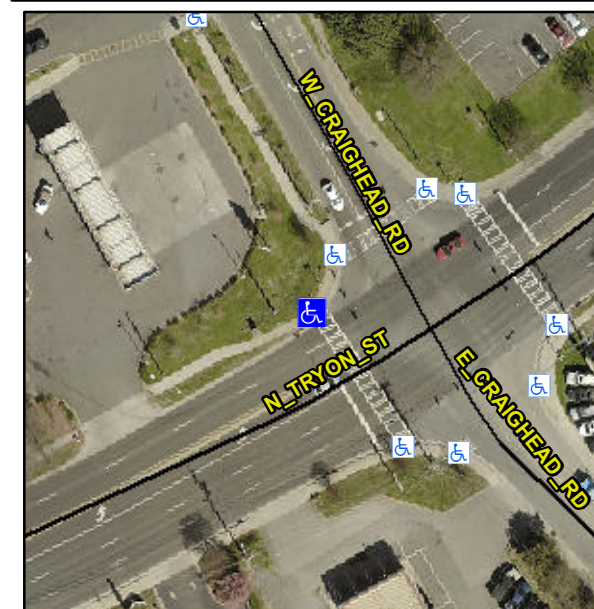
**Not Found, R304.5.1**

Compliance	Description	Data	Compliance	Description	Data
N/A	Ramp Length (in)	72.5	Yes	Ramp Slope (%)	5.3
No	Ramp Width (in)	40.5	Yes	Ramp XSlope (%)	0.4
N/A	Flare Type LT	N/A	N/A	Flare Type RT	N/A
N/A	Flare Slope LT (%)	N/A	N/A	Flare Slope RT (%)	N/A
N/A	Flare Traversable LT?	N/A	N/A	Flare Traversable RT?	N/A
N/A	Landing Length (in)	N/A	N/A	DWS Provided?	N/A
N/A	Landing Width (in)	N/A	N/A	DWS Contrast?	N/A
N/A	Landing Slope (%)	N/A	N/A	DWS Length (in)	N/A
N/A	Landing X Slope (%)	N/A	N/A	DWS Full Width?	N/A
N/A	Landing Curb? (Y/N)	N/A	N/A	DWS Offset (in)	N/A
N/A	Shared Landing?	N/A			
N/A	Gutter Ponding?	N/A	N/A	Gutter Slope (%)	N/A
N/A	Gutter Lip Ht (in)	N/A	N/A	Gutter X Slope (%)	N/A
N/A	Painted X Walk1?	Yes	N/A	Painted X Walk2?	N/A
	X Walk 1 Direction	To SE		X Walk 2 Direction	N/A
N/A	X Walk 1 Width (in)	90.5	N/A	X Walk 2 Width (in)	N/A
	X Walk 1 Slope (%)	1.9		X Walk 2 Slope (%)	N/A
	X Walk 1 X Slope (%)	0.3		X Walk 2 X Slope (%)	N/A

N/A	Ramp inside XWalk1?	Yes	N/A	Ramp inside XWalk2?	N/A
	Road Slope (%)	N/A	N/A	Clear Space?	N/A
	Road X Slope (%)	N/A	N/A	Clear Space to XWalk (in)	N/A
N/A	Any Obstructions?	N/A	N/A	Storm Grate/Utility Hazard?	N/A
	Obstruction Type			Storm Grate/Utility Type	
		N/A			N/A
			Yes	Surface Condition? (G/P)	Good

**Remove & Replace Entire Ramp.**

Total Cost: \$ 1850.00
