Access Compliance Report

Public Rights-of-Way

(Curb Ramps)

Intersection ID: 44916	Main Street: FOX_POINT_DR	Cross Street: BERRYBROOK_LN	Location: NW
ADA ID: 969D968E0700	Ramp Type: PerpDiag	Initial Pass/Fail: Fail	Overall Compliance: No
		Severity Score: 17.5

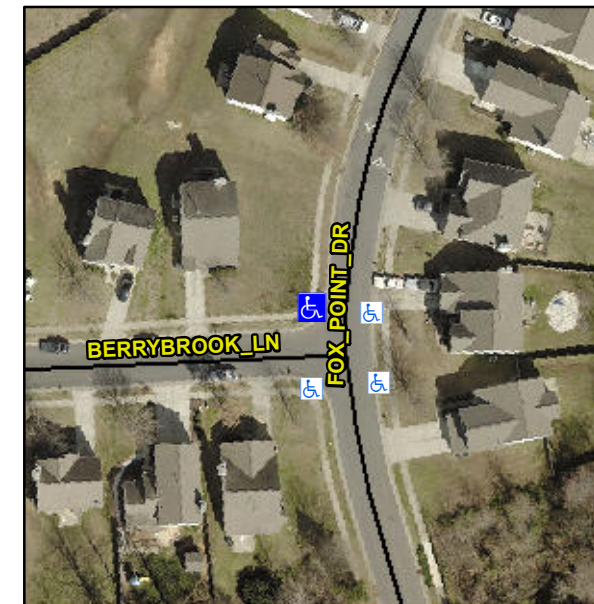
Compliance	Description	Data	Compliance	Description	Data
N/A	Ramp Length (in)	53.0	Yes	Ramp Slope (%)	6.3
No	Ramp Width (in)	35.0	Yes	Ramp XSlope (%)	1.6
N/A	Flare Type LT	N/A	N/A	Flare Type RT	N/A
N/A	Flare Slope LT (%)	N/A	N/A	Flare Slope RT (%)	N/A
N/A	Flare Traversable LT?	N/A	N/A	Flare Traversable RT?	N/A
N/A	Landing Length (in)	N/A	N/A	DWS Provided?	N/A
N/A	Landing Width (in)	N/A	N/A	DWS Contrast?	N/A
N/A	Landing Slope (%)	N/A	N/A	DWS Length (in)	N/A
N/A	Landing X Slope (%)	N/A	N/A	DWS Full Width?	N/A
N/A	Landing Curb? (Y/N)	N/A	N/A	DWS Offset (in)	N/A
N/A	Shared Landing?	N/A			
N/A	Gutter Ponding?	N/A	N/A	Gutter Slope (%)	N/A
N/A	Gutter Lip Ht (in)	N/A	N/A	Gutter X Slope (%)	N/A
N/A	Painted X Walk1?	No	N/A	Painted X Walk2?	No
	X Walk 1 Direction	To S		X Walk 2 Direction	To E
N/A	X Walk 1 Width (in)	N/A	N/A	X Walk 2 Width (in)	N/A
	X Walk 1 Slope (%)	1.7		X Walk 2 Slope (%)	4.5
	X Walk 1 X Slope (%)	4.4		X Walk 2 X Slope (%)	2.9

N/A	Ramp inside XWalk1?	N/A	N/A	Ramp inside XWalk2?	N/A
	Road Slope (%)	3.9	N/A	Clear Space?	N/A
	Road X Slope (%)	2.1	N/A	Clear Space to XWalk (in)	N/A
N/A	Any Obstructions?	N/A	N/A	Storm Grate/Utility Hazard?	N/A
	Obstruction Type			Storm Grate/Utility Type	
		N/A			N/A
		Yes		Surface Condition? (G/P)	Good

Possible Solutions:

Remove & Replace Curb Ramp With Two New Directional Ramps or Equivalent.

R304.5.1
