# Access Compliance Report

## Public Rights-of-Way

### (Curb Ramps)

| Intersection ID: 10024718 | Main Street: DEBORAH_DR | Cross Street: N/A | Location: N |

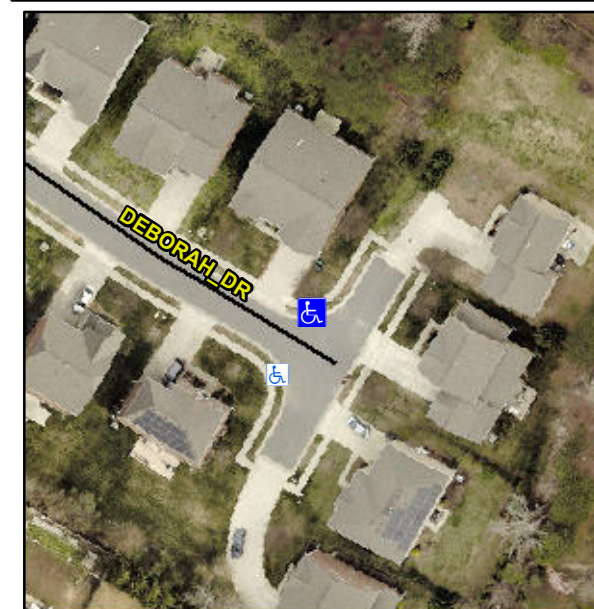
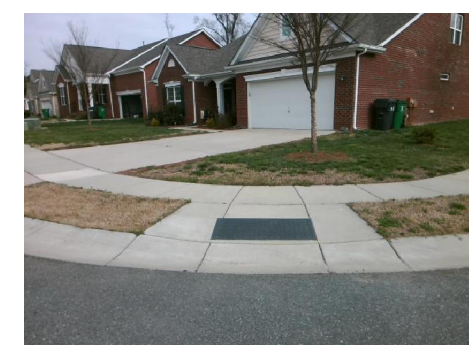
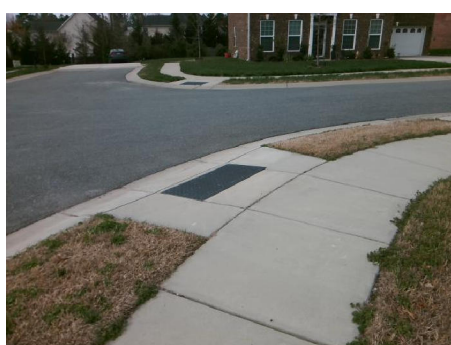
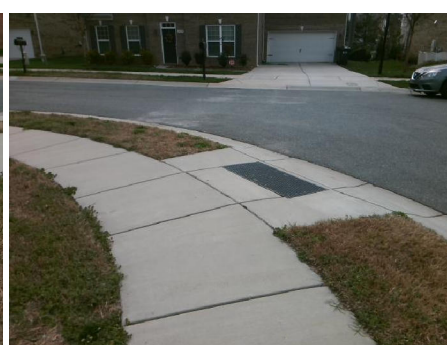
| ADA ID: 969DCFEE0A39 | Ramp Type: Perp | Initial Pass/Fail: Fail | Overall Compliance: No |

**Not Found, R304.5.1, R304.2.2**

| Compliance | Description | Data | Compliance | Description | Data |
|---|---|---|---|---|---|
| N/A | Ramp Length (in) | 48.0 | No | Ramp Slope (%) | 10.3 |
| No | Ramp Width (in) | 42.0 | Yes | Ramp XSlope (%) | 0.0 |

**Remove & Replace Entire Ramp.**

Total Cost: \$ 1850.00
