Access Compliance Report

Public Rights-of-Way

(Curb Ramps)

Intersection ID: 14648	Main Street: EAST_BV	Cross Street: LENNOX_AV	Location: NE
ADA ID: 969FB18E1BE1	Ramp Type: Perp	Initial Pass/Fail: Fail	Overall Compliance: No
Severity Score: 12.5			
Codes/Mitigation Info/Possible Solution		Field Measurements/Component Compliance

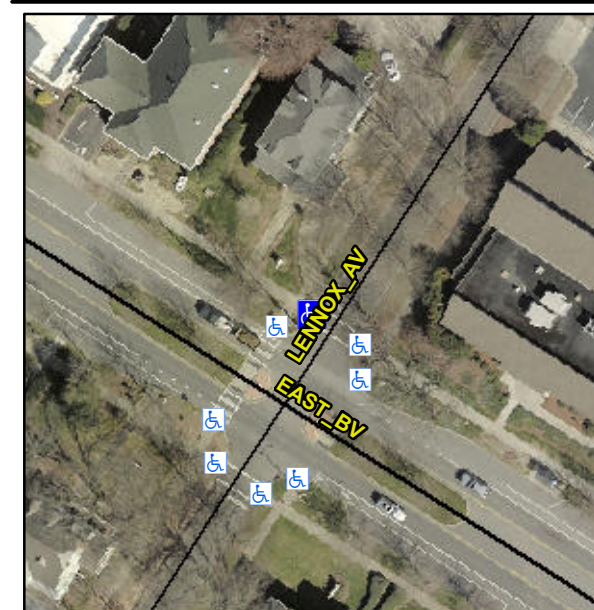
Not Found, R304.2.2

Compliance	Description	Data	Compliance	Description	Data
N/A	Ramp Length (in)	67.0	No	Ramp Slope (%)	9.7
Yes	Ramp Width (in)	78.0	Yes	Ramp XSlope (%)	1.4
N/A	Flare Type LT	N/A	N/A	Flare Type RT	N/A
N/A	Flare Slope LT (%)	N/A	N/A	Flare Slope RT (%)	N/A
N/A	Flare Traversable LT?	N/A	N/A	Flare Traversable RT?	N/A
N/A	Landing Length (in)	N/A	N/A	DWS Provided?	N/A
N/A	Landing Width (in)	N/A	N/A	DWS Contrast?	N/A
N/A	Landing Slope (%)	N/A	N/A	DWS Length (in)	N/A
N/A	Landing X Slope (%)	N/A	N/A	DWS Full Width?	N/A
N/A	Landing Curb? (Y/N)	N/A	N/A	DWS Offset (in)	N/A
N/A	Shared Landing?	N/A			
N/A	Gutter Ponding?	N/A	N/A	Gutter Slope (%)	N/A
N/A	Gutter Lip Ht (in)	N/A	N/A	Gutter X Slope (%)	N/A
N/A	Painted X Walk1?	No	N/A	Painted X Walk2?	N/A
	X Walk 1 Direction	To SE		X Walk 2 Direction	N/A
N/A	X Walk 1 Width (in)	N/A	N/A	X Walk 2 Width (in)	N/A
	X Walk 1 Slope (%)	2.4		X Walk 2 Slope (%)	N/A
	X Walk 1 X Slope (%)	0.0		X Walk 2 X Slope (%)	N/A

N/A	Ramp inside XWalk1?	N/A	N/A	Ramp inside XWalk2?	N/A
	Road Slope (%)	N/A	N/A	Clear Space?	N/A
	Road X Slope (%)	N/A	N/A	Clear Space to XWalk (in)	N/A
N/A	Any Obstructions?	N/A	N/A	Storm Grate/Utility Hazard?	N/A
	Obstruction Type			Storm Grate/Utility Type	
		N/A			N/A
			Yes	Surface Condition? (G/P)	Good

Remove & Replace Entire Ramp.

Total Cost: \$ 1850.00
