# Access Compliance Report

## Public Rights-of-Way

### (Curb Ramps)

Intersection ID: 9786	Main Street: E_37TH_ST	Cross Street: N_DAVIDSON_ST	Location: E
ADA ID: 96A6639F9F1B	Ramp Type: Perp	Initial Pass/Fail: Fail	Overall Compliance: No
Severity Score: 13.75			
Codes/Mitigation Info/Possible Solution		Field Measurements/Component Compliance

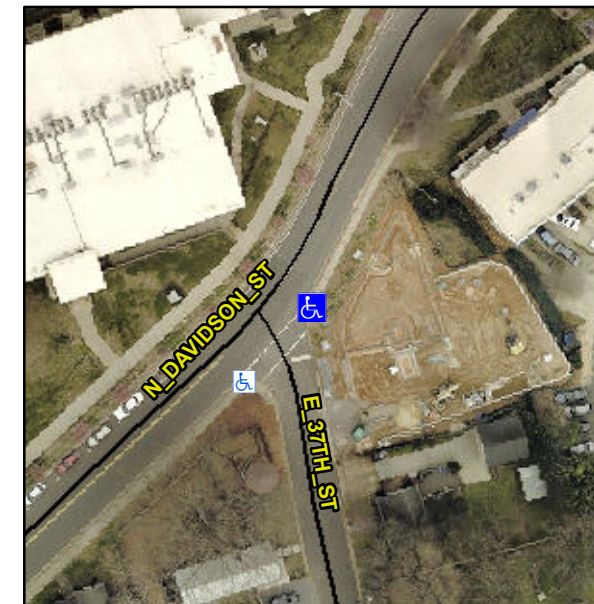
**Not Found, R304.2.2, R304.5.3**

Compliance	Description	Data	Compliance	Description	Data
N/A	Ramp Length (in)	61.0	No	Ramp Slope (%)	10.8
Yes	Ramp Width (in)	48.0	No	Ramp XSlope (%)	3.3
N/A	Flare Type LT	N/A	N/A	Flare Type RT	N/A
N/A	Flare Slope LT (%)	N/A	N/A	Flare Slope RT (%)	N/A
N/A	Flare Traversable LT?	N/A	N/A	Flare Traversable RT?	N/A
N/A	Landing Length (in)	N/A	N/A	DWS Provided?	N/A
N/A	Landing Width (in)	N/A	N/A	DWS Contrast?	N/A
N/A	Landing Slope (%)	N/A	N/A	DWS Length (in)	N/A
N/A	Landing X Slope (%)	N/A	N/A	DWS Full Width?	N/A
N/A	Landing Curb? (Y/N)	N/A	N/A	DWS Offset (in)	N/A
N/A	Shared Landing?	N/A			
N/A	Gutter Ponding?	N/A	N/A	Gutter Slope (%)	N/A
N/A	Gutter Lip Ht (in)	N/A	N/A	Gutter X Slope (%)	N/A
N/A	Painted X Walk1?	Yes	N/A	Painted X Walk2?	N/A
	X Walk 1 Direction	To SW		X Walk 2 Direction	N/A
N/A	X Walk 1 Width (in)	107.0	N/A	X Walk 2 Width (in)	N/A
	X Walk 1 Slope (%)	5.8		X Walk 2 Slope (%)	N/A
	X Walk 1 X Slope (%)	2.3		X Walk 2 X Slope (%)	N/A

N/A	Ramp inside XWalk1?	Yes	N/A	Ramp inside XWalk2?	N/A
	Road Slope (%)	N/A	N/A	Clear Space?	N/A
	Road X Slope (%)	N/A	N/A	Clear Space to XWalk (in)	N/A
N/A	Any Obstructions?	N/A	N/A	Storm Grate/Utility Hazard?	N/A
	Obstruction Type			Storm Grate/Utility Type	
		N/A			N/A
		Yes		Surface Condition? (G/P)	Good

**Remove & Replace Entire Ramp.**

Total Cost: \$ 1850.00
