Access Compliance Report Public Rights-of-Way (Curb Ramps)

Intersection ID: 23740 Main Street: PARK_RD Cross Street: SMITHFIELD_CHURCH_RD Location: NW ADA ID: 96AF61FD053C Ramp Type: PerpDiag Initial Pass/Fail: Fail **Overall Compliance: No** Severity Score: 13.75

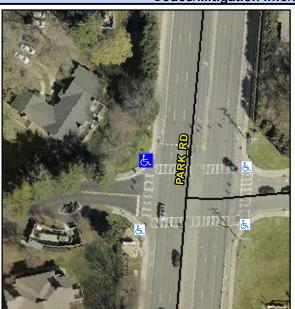
Field Measurements/Component Compliance						
	Compliance Description		Data	Comp	oliance Description	Data
	N/A	Ramp Length (in)	60.0	No	Ramp Slope (%)	9.0
	Yes	Ramp Width (in)	48.0	No	Ramp XSlope (%)	4.1
	N/A	Flare Type LT	N/A	N/A	Flare Type RT	N/A
	N/A	Flare Slope LT (%)	N/A	N/A	Flare Slope RT (%)	N/A
	N/A	Flare Traversable LT?	N/A	N/A	Flare Traversable RT?	N/A
	N/A	Landing Length (in)	N/A	N/A	DWS Provided?	N/A
	N/A	Landing Width (in)	N/A	N/A	DWS Contrast?	N/A
	N/A	Landing Slope (%)	N/A	N/A	DWS Length (in)	N/A
	N/A	Landing X Slope (%)	N/A	N/A	DWS Full Width?	N/A
	N/A	Landing Curb? (Y/N)	N/A	N/A	DWS Offset (in)	N/A
	N/A	Shared Landing?	N/A			
	N/A	Gutter Ponding?	N/A	N/A	Gutter Slope (%)	N/A
	N/A	Gutter Lip Ht (in)	N/A	N/A	Gutter X Slope (%)	N/A
	N/A	Painted X Walk1?	Yes	N/A	Painted X Walk2?	Yes
		X Walk 1 Direction	To SW		X Walk 2 Direction	To SE
	N/A	X Walk 1 Width (in)	104.0	N/A	X Walk 2 Width (in)	100.0

X Walk 1 Slope (%)	0.8		X Walk 2 Slope (%)	7.1
		X Walk 1 X Slope (%)	7.1		X Walk 2 X Slope (%)	2.1
	N/A	Ramp inside XWalk1?	Yes	N/A	Ramp inside XWalk2?	No
		Road Slope (%)	3.9	N/A	Clear Space?	N/A
		Road X Slope (%)	8.8	N/A	Clear Space to XWalk (in)	N/A
	N/A	Any Obstructions?	N/A	N/A	Storm Grate/Utility Hazard?	N/A
		Obstruction Type			Storm Grate/Utility Type	
			N/A			N/A
				Yes	Surface Condition? (G/P)	Good
F		4 6

Possible Solutions: Remove & Replace Curb Ramp With Two New Directional Ramps or Equivalent. Restripe Crosswalk. Surveyor Notes: N/A PROW/ADA: R304.2.2, R304.5.3
