# Access Compliance Report

## Public Rights-of-Way

### (Curb Ramps)

Intersection ID: 53629	Main Street: PROVIDENCE_RD_WEST	Cross Street: CAMBRIDGE_FOREST_CT	Location: SE
ADA ID: 96B05F720BD8	Ramp Type: PerpDiag	Initial Pass/Fail: Fail	Overall Compliance: No
Codes/Mitigation Info/Possible Solution		Field Measurements/Component Compliance	
Severity Score: 21.25

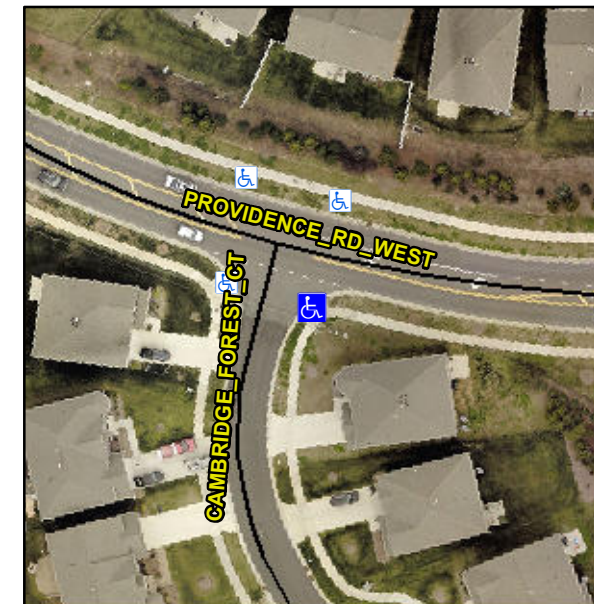
**Not Found, R304.5.1, R304.5.3**

Compliance	Description	Data	Compliance	Description	Data
N/A	Ramp Length (in)	48.0	Yes	Ramp Slope (%)	5.6
No	Ramp Width (in)	46.5	No	Ramp XSlope (%)	6.9
N/A	Flare Type LT	N/A	N/A	Flare Type RT	N/A
N/A	Flare Slope LT (%)	N/A	N/A	Flare Slope RT (%)	N/A
N/A	Flare Traversable LT?	N/A	N/A	Flare Traversable RT?	N/A
N/A	Landing Length (in)	N/A	N/A	DWS Provided?	N/A
N/A	Landing Width (in)	N/A	N/A	DWS Contrast?	N/A
N/A	Landing Slope (%)	N/A	N/A	DWS Length (in)	N/A
N/A	Landing X Slope (%)	N/A	N/A	DWS Full Width?	N/A
N/A	Landing Curb? (Y/N)	N/A	N/A	DWS Offset (in)	N/A
N/A	Shared Landing?	N/A			
N/A	Gutter Ponding?	N/A	N/A	Gutter Slope (%)	N/A
N/A	Gutter Lip Ht (in)	N/A	N/A	Gutter X Slope (%)	N/A
N/A	Painted X Walk1?	No	N/A	Painted X Walk2?	No
	X Walk 1 Direction	To NE		X Walk 2 Direction	To NW
N/A	X Walk 1 Width (in)	N/A	N/A	X Walk 2 Width (in)	N/A
	X Walk 1 Slope (%)	2.2		X Walk 2 Slope (%)	3.5
	X Walk 1 X Slope (%)	3.1		X Walk 2 X Slope (%)	4.3

N/A	Ramp inside XWalk1?	N/A	N/A	Ramp inside XWalk2?	N/A
	Road Slope (%)	4.0	N/A	Clear Space?	N/A
	Road X Slope (%)	1.1	N/A	Clear Space to XWalk (in)	N/A
N/A	Any Obstructions?	N/A	N/A	Storm Grate/Utility Hazard?	N/A
	Obstruction Type			Storm Grate/Utility Type	
		N/A			N/A
			Yes	Surface Condition? (G/P)	Good

**Remove & Replace Curb Ramp With Two New Directional Ramps or Equivalent.**
