Access Compliance Report

Public Rights-of-Way

(Curb Ramps)

Intersection ID: 10025051	Main Street: DOSTER_AV	Cross Street: N/A	Location: NW
ADA ID: 96BAE55F616C	Ramp Type: Directional1	Initial Pass/Fail: Fail	Overall Compliance: No
		Severity Score: 12.5

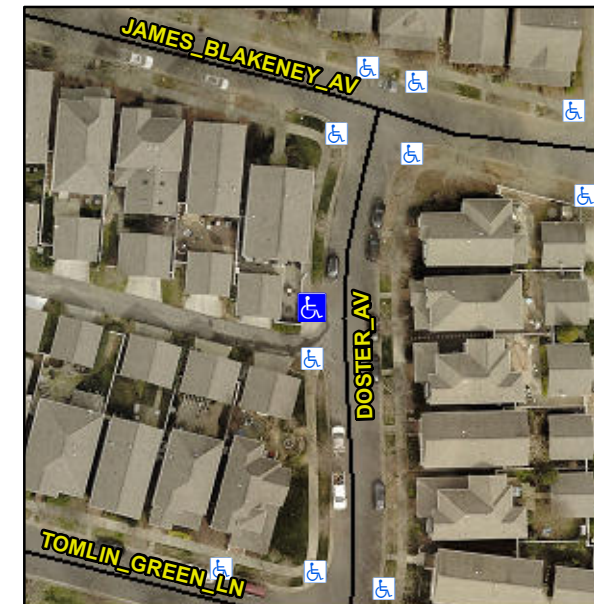
R304.5.3

Compliance	Description	Data	Compliance	Description	Data
N/A	Ramp Length (in)	132.0	N/A	Grade Break?	N/A
Yes	Ramp Width (in)	50.0	N/A	Grade Break Slope (%)	0.0
Yes	Ramp Slope (%)	7.9	N/A	Grade Break XSlope (%)	0.0
No	Ramp XSlope (%)	5.2			
N/A	Flare Type LT	N/A	N/A	Flare Type RT	N/A
N/A	Flare Slope LT (%)	N/A	N/A	Flare Slope RT (%)	0.0
N/A	Flare Traversable LT?	N/A	N/A	Flare Traversable RT?	N/A
N/A	Landing Length (in)	0.0	N/A	DWS Provided?	N/A
N/A	Landing Width (in)	0.0	N/A	DWS Contrast?	N/A
N/A	Landing Slope (%)	0.0	N/A	DWS Length (in)	N/A
N/A	Landing X Slope (%)	0.0	N/A	DWS Full Width?	N/A
N/A	Landing Curb? (Y/N)	N/A	N/A	DWS Offset LT (in)	N/A
N/A	Shared Landing?	N/A	N/A	DWS Offset RT (in)	N/A
N/A	Gutter Ponding?	0.0	N/A	Gutter Slope (%)	N/A
N/A	Gutter Lip Ht (in)	0.0	N/A	Gutter X Slope (%)	N/A
N/A	Painted X Walk1?	No		Road Slope (%)	0.3
	X Walk 1 Direction	To S		Road X Slope (%)	0.1
	X Walk 1 Width (in)	N/A		Clear Space?	N/A

X Walk 1 Slope (%)	0.3	N/A	Clear Space to XWalk (in)	N/A
	X Walk 1 X Slope (%)	0.1	N/A	Storm Grate/Utility Hazard?	N/A
N/A	Ramp inside XWalk1?	N/A		Storm Grate/Utility Type	
N/A	Any Obstructions?	N/A			N/A
	Obstruction Type		Yes	Surface Condition? (G/P)	Good
			N/A	Curb Slope (%)	0.2

Possible Solutions:

Remove & Replace Entire Ramp.
