# Access Compliance Report

## Public Rights-of-Way

### (Curb Ramps)

| ADA ID: 96C081E2F3D2 | Ramp Type: Directional2 | Initial Pass/Fail: Pass | Overall Compliance: No |

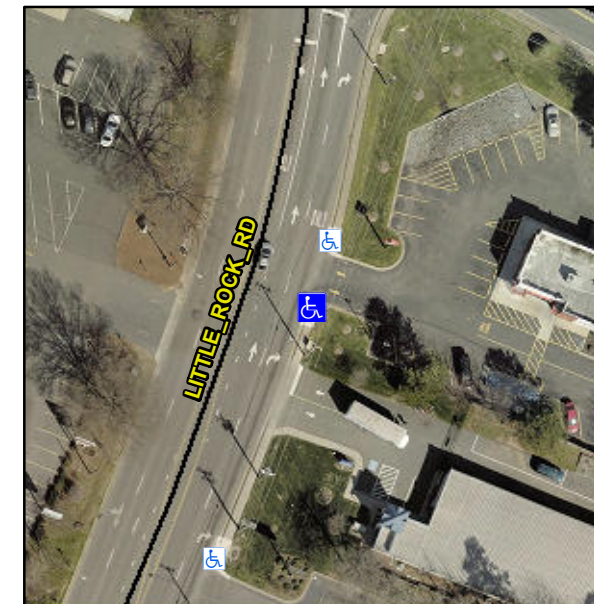
**R304.5.3**

| Compliance | Description | Data | Compliance | Description | Data |
|---|---|---|---|---|---|
| Yes | Gutter Lip Ht (in) | 0.0 | No | Gutter X Slope (%) | 2.1 |

**Remove & Replace Gutter.**
