# Access Compliance Report

## Public Rights-of-Way

### (Curb Ramps)

Intersection ID: 10027164	Main Street: GATEWOOD_OAKS_DR	Cross Street: N/A	Location: NE
ADA ID: 96C41E8C396D	Ramp Type: Perp	Initial Pass/Fail: Fail	Overall Compliance: No
Severity Score: 12.5			
Codes/Mitigation Info/Possible Solution		Field Measurements/Component Compliance

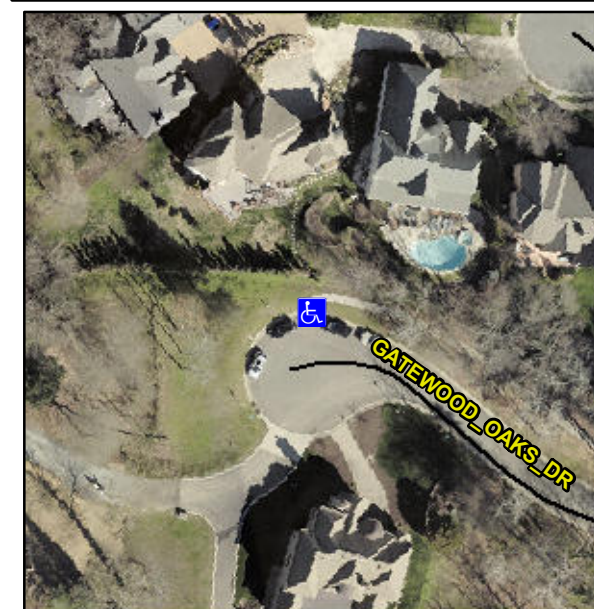
**Not Found, R304.2.2**

Compliance	Description	Data	Compliance	Description	Data
N/A	Ramp Length (in)	69.0	No	Ramp Slope (%)	9.7
Yes	Ramp Width (in)	48.0	Yes	Ramp XSlope (%)	0.9
N/A	Flare Type LT	N/A	N/A	Flare Type RT	N/A
N/A	Flare Slope LT (%)	N/A	N/A	Flare Slope RT (%)	N/A
N/A	Flare Traversable LT?	N/A	N/A	Flare Traversable RT?	N/A
N/A	Landing Length (in)	N/A	N/A	DWS Provided?	N/A
N/A	Landing Width (in)	N/A	N/A	DWS Contrast?	N/A
N/A	Landing Slope (%)	N/A	N/A	DWS Length (in)	N/A
N/A	Landing X Slope (%)	N/A	N/A	DWS Full Width?	N/A
N/A	Landing Curb? (Y/N)	N/A	N/A	DWS Offset (in)	N/A
N/A	Shared Landing?	N/A			
N/A	Gutter Ponding?	N/A	N/A	Gutter Slope (%)	N/A
N/A	Gutter Lip Ht (in)	3.0	N/A	Gutter X Slope (%)	N/A
N/A	Painted X Walk1?	No	N/A	Painted X Walk2?	N/A
	X Walk 1 Direction	To S		X Walk 2 Direction	N/A
N/A	X Walk 1 Width (in)	N/A	N/A	X Walk 2 Width (in)	N/A
	X Walk 1 Slope (%)	2.3		X Walk 2 Slope (%)	N/A
	X Walk 1 X Slope (%)	4.2		X Walk 2 X Slope (%)	N/A

**Remove & Replace Entire Ramp.**

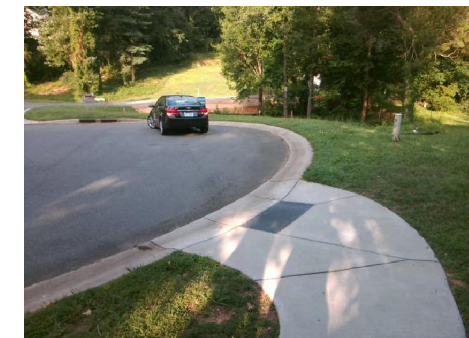
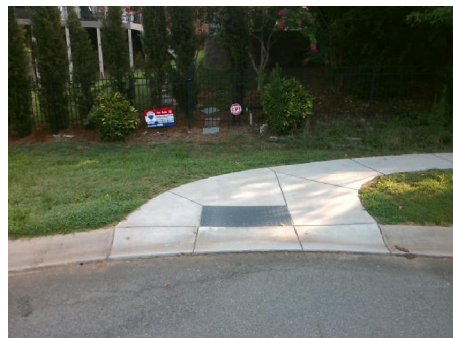
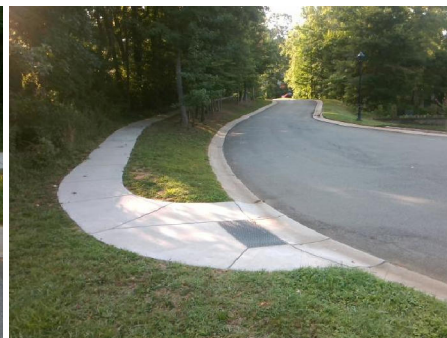
N/A	Ramp inside XWalk1?	N/A	N/A	Ramp inside XWalk2?	N/A
	Road Slope (%)	N/A	N/A	Clear Space?	N/A
	Road X Slope (%)	N/A	N/A	Clear Space to XWalk (in)	N/A
N/A	Any Obstructions?	N/A	N/A	Storm Grate/Utility Hazard?	N/A
	Obstruction Type			Storm Grate/Utility Type	
		N/A			N/A
			Yes	Surface Condition? (G/P)	Good
