# Access Compliance Report

## Public Rights-of-Way

### (Curb Ramps)

| Intersection ID: 10020180 | Main Street: AUBURN_AV | Cross Street: N/A | Location: E |

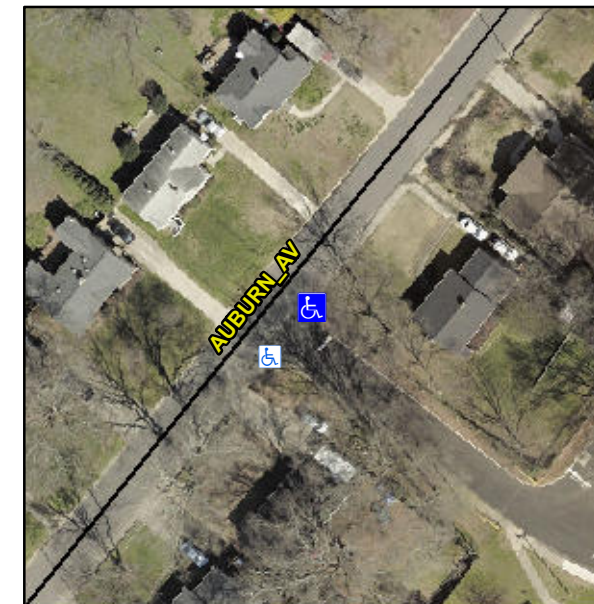
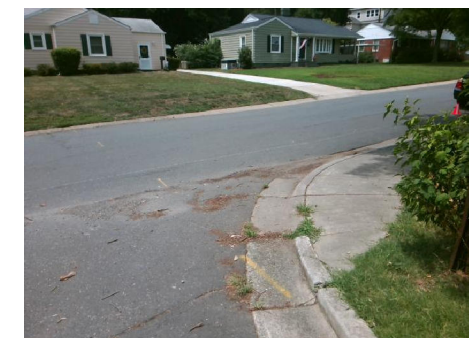
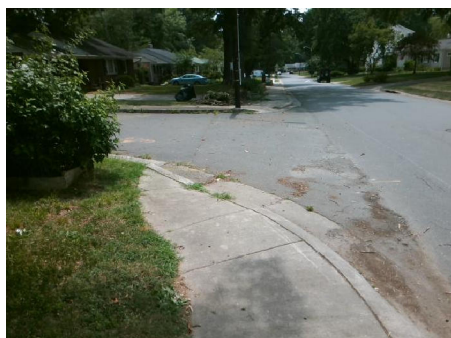
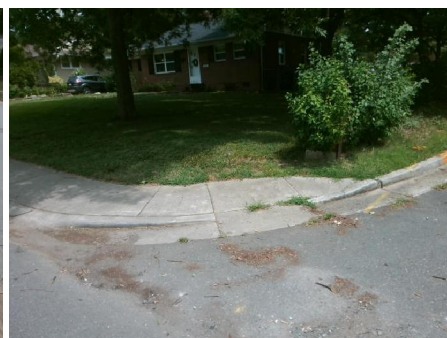
| ADA ID: 96C61C6A701E | Ramp Type: PerpDiag | Initial Pass/Fail: Fail | Overall Compliance: No |
| Severity Score: 46.25 | | | |

**Not Found, R304.5.1, R304.2.2, R304.5.3**

| Compliance | Description | Data | Compliance | Description | Data |
|---|---|---|---|---|---|
| N/A | Ramp Length (in) | 32.0 | No | Ramp Slope (%) | 15.7 |
| No | Ramp Width (in) | 44.0 | No | Ramp XSlope (%) | 5.6 |

**Remove & Replace Curb Ramp With Two New Directional Ramps or Equivalent.**

Total Cost: \$ 3200.00
