Access Compliance Report

Public Rights-of-Way

(Curb Ramps)

| Intersection ID: 5200 | Main Street: MT_HOLLY-HUNTERSVILLE_RD | Cross Street: NORTHWOODS_FOREST_DR | Location: NW |

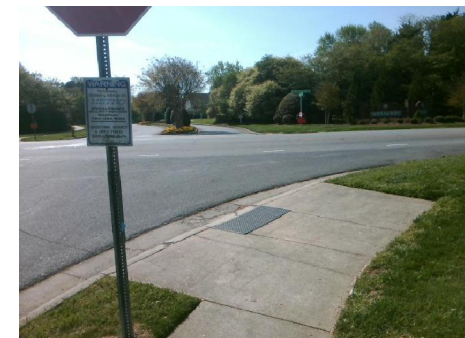
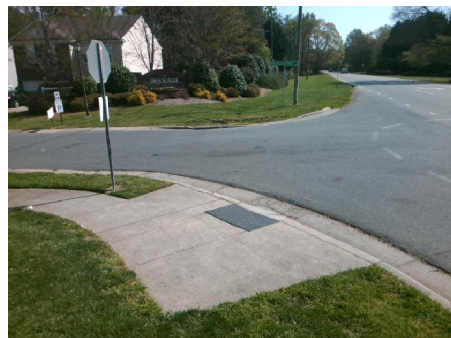
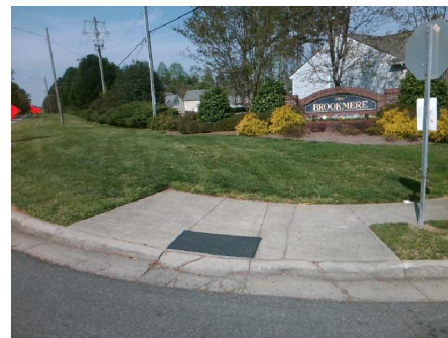
Not Found, R304.5.1, R304.5.3

| Compliance | Description | Data | Compliance | Description | Data |
|---|---|---|---|---|---|
| No | Ramp Width (in) | 40.5 | No | BlendTrans XSlope (%) | 6.7 |
| | | | No | Curb Slope (%) | 16.0 |

Remove & Replace Curb Ramp With Two New Directional Ramps or Equivalent.
