# Access Compliance Report

## Public Rights-of-Way

### (Curb Ramps)

| Intersection ID: 30478 | Main Street: CREEK_TURN_DR | Cross Street: EBULLIENT_ST | Location: SE |

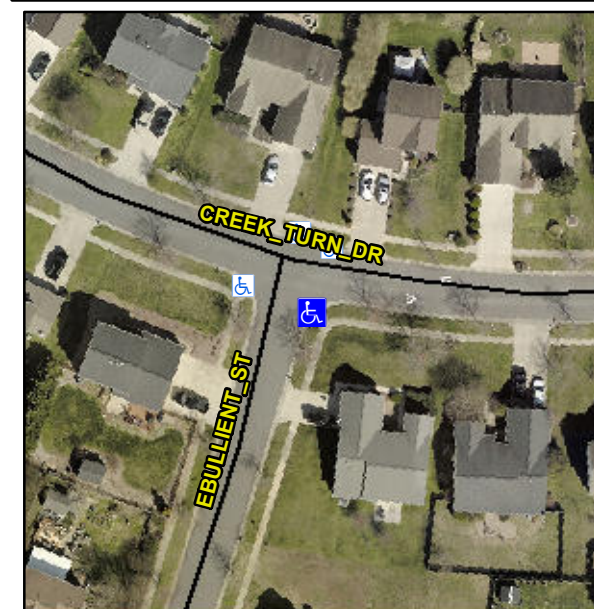
**R304.5.1, R304.2.2, R304.5.3**

| Compliance | Description | Data | Compliance | Description | Data |
|---|---|---|---|---|---|
| N/A | Ramp Length (in) | 81.0 | No | Ramp Slope (%) | 10.9 |
| No | Ramp Width (in) | 30.5 | No | Ramp XSlope (%) | 4.2 |

**Remove & Replace Curb Ramp With Two New Directional Ramps or Equivalent.**
