Access Compliance Report

Public Rights-of-Way (Curb Ramps)

Intersection ID: 52986	Main Street: GREYTHORNE DR	Cross Street: LANDING_PLACE_LN	Location: NE
ADA ID: 96F6180F6521	Ramp Type: BlendTrans1	Initial Pass/Fail: Fail	Overall Compliance: No
		Severity Score: 12.5

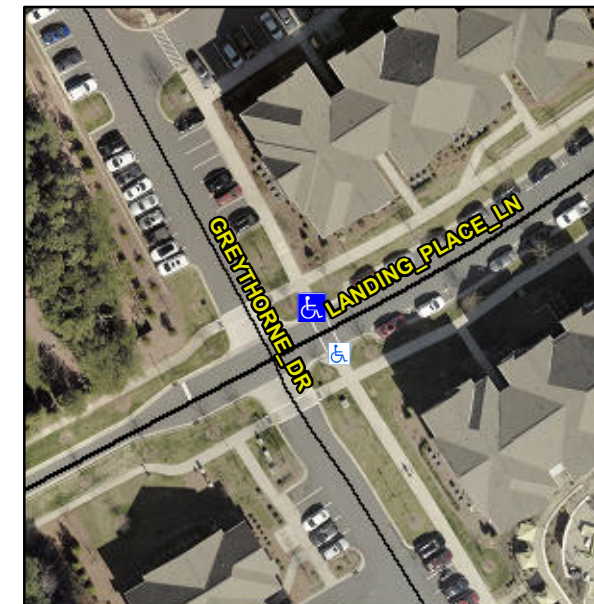
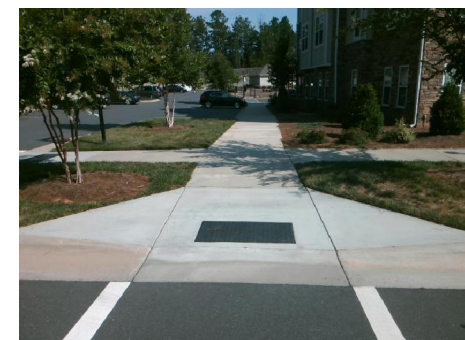
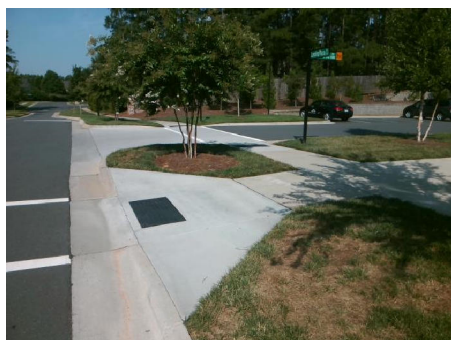
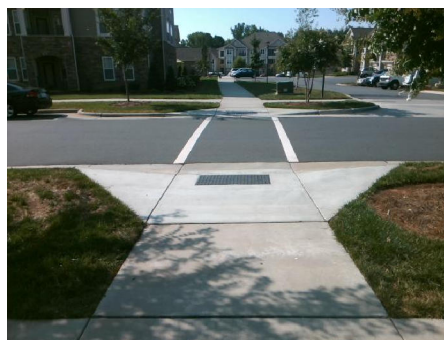
Not Found, R304.5.3

Compliance	Description	Data	Compliance	Description	Data
N/A	Ramp Length (in)	87.0	Yes	BlendTrans Slope (%)	3.8
Yes	Ramp Width (in)	84.0	No	BlendTrans XSlope (%)	5.5
N/A	Flare Type LT	N/A	N/A	Flare Type RT	N/A
N/A	Flare Slope LT (%)	N/A	N/A	Flare Slope RT (%)	N/A
N/A	Flare Traversable LT?	N/A	N/A	Flare Traversable RT?	N/A
N/A	Landing Length (in)	N/A	N/A	DWS Provided?	N/A
N/A	Landing Width (in)	N/A	N/A	DWS Contrast?	N/A
N/A	Landing Slope (%)	N/A	N/A	DWS Length (in)	N/A
N/A	Landing X Slope (%)	N/A	N/A	DWS Full Width?	N/A
N/A	Landing Curb? (Y/N)	N/A	N/A	DWS Offset (in)	N/A
N/A	Shared Landing?	N/A			
N/A	Gutter Ponding?	N/A	N/A	Gutter Slope (%)	N/A
N/A	Gutter Lip Ht (in)	N/A	N/A	Gutter X Slope (%)	N/A
N/A	Painted X Walk1?	Yes	N/A	Painted X Walk2?	N/A
	X Walk 1 Direction	To SE		X Walk 2 Direction	N/A
	X Walk 1 Width (in)	82.0		X Walk 2 Width (in)	N/A
	X Walk 1 Slope (%)	1.1		X Walk 2 Slope (%)	N/A
	X Walk 1 X Slope (%)	0.9		X Walk 2 X Slope (%)	N/A

N/A	Ramp inside XWalk1?	Yes	N/A	Ramp inside XWalk2?	N/A
	Road Slope (%)	0.9		Clear Space?	N/A
	Road X Slope (%)	1.1	N/A	Clear Space to XWalk (in)	N/A
N/A	Any Obstructions?	N/A	N/A	Storm Grate/Utility Hazard?	N/A
	Obstruction Type			Storm Grate/Utility Type	
		N/A			N/A
			Yes	Surface Condition? (G/P)	Good
			No	Curb Slope (%)	12.2

Remove & Replace Curb Ramp With Two New Directional Ramps or Equivalent.

Total Cost: \$ 3200.00
