Access Compliance Report

Public Rights-of-Way (Curb Ramps)

Intersection ID: N/A	Main Street: WEST_BV	Cross Street: HOLABIRD_LN	Location: W
ADA ID: 96F7523CCF0D	Ramp Type: Directional1	Initial Pass/Fail: Fail	Overall Compliance: No
Severity Score: 46.25			
Codes/Mitigation Info/Possible Solution		Field Measurements/Component Compliance

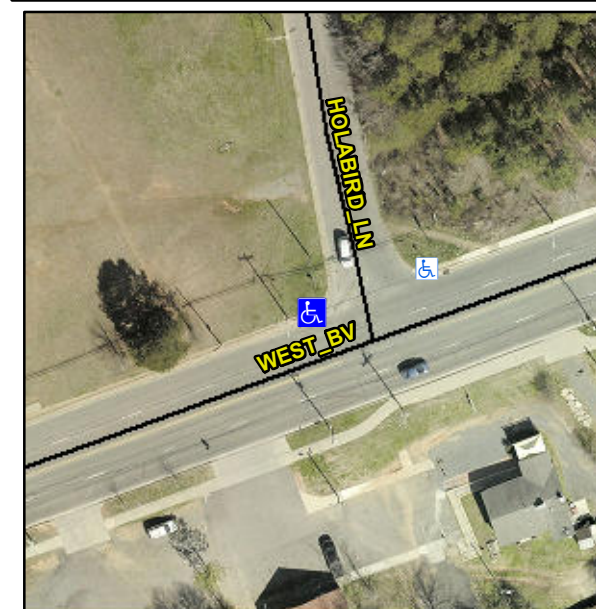
Compliance	Description	Data	Compliance	Description	Data
N/A	Ramp Length (in)	40.0	N/A	Grade Break?	N/A
No	Ramp Width (in)	36.0	N/A	Grade Break Slope (%)	0.0
No	Ramp Slope (%)	11.8	N/A	Grade Break XSlope (%)	0.0
No	Ramp XSlope (%)	14.9			
N/A	Flare Type LT	N/A	N/A	Flare Type RT	N/A
N/A	Flare Slope LT (%)	N/A	N/A	Flare Slope RT (%)	0.0
N/A	Flare Traversable LT?	N/A	N/A	Flare Traversable RT?	N/A
N/A	Landing Length (in)	0.0	N/A	DWS Provided?	N/A
N/A	Landing Width (in)	0.0	N/A	DWS Contrast?	N/A
N/A	Landing Slope (%)	0.0	N/A	DWS Length (in)	N/A
N/A	Landing X Slope (%)	0.0	N/A	DWS Full Width?	N/A
N/A	Landing Curb? (Y/N)	N/A	N/A	DWS Offset LT (in)	N/A
N/A	Shared Landing?	N/A	N/A	DWS Offset RT (in)	N/A
N/A	Gutter Ponding?	0.0	N/A	Gutter Slope (%)	N/A
N/A	Gutter Lip Ht (in)	0.0	N/A	Gutter X Slope (%)	N/A
N/A	Painted X Walk1?	No		Road Slope (%)	3.3
	X Walk 1 Direction	To NE		Road X Slope (%)	5.2
	X Walk 1 Width (in)	N/A		Clear Space?	N/A

X Walk 1 Slope (%)	3.3	N/A	Clear Space to XWalk (in)	N/A
	X Walk 1 X Slope (%)	5.2	N/A	Storm Grate/Utility Hazard?	N/A
N/A	Ramp inside XWalk1?	N/A		Storm Grate/Utility Type	
N/A	Any Obstructions?	N/A			N/A
	Obstruction Type		Yes	Surface Condition? (G/P)	Good
			N/A	Curb Slope (%)	1.2

Remove & Replace Entire Ramp.

R304.5.1, R304.2.2, R304.5.3
