# Access Compliance Report

## Public Rights-of-Way

### (Curb Ramps)

| Intersection ID: 11536 | Main Street: CONNECTICUT_AV | Cross Street: HILLIARD_DR | Location: SE |

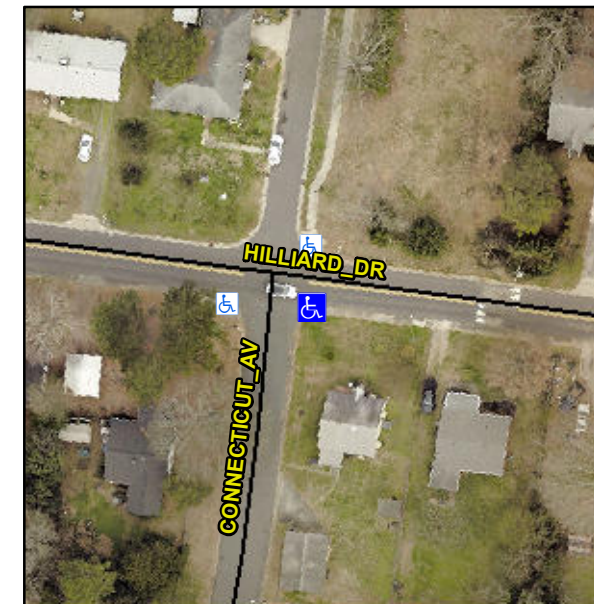
| ADA ID: 96FF5C3155BF | Ramp Type: PerpDiag | Initial Pass/Fail: Fail | Overall Compliance: No |
| | | Severity Score: 10 | |

| Compliance | Description | Data | Compliance | Description | Data |
|---|---|---|---|---|---|
| N/A | Ramp Length (in) | 49.0 | Yes | Ramp Slope (%) | 7.2 |
| No | Ramp Width (in) | 38.0 | No | Ramp XSlope (%) | 4.2 |

Possible Solutions:

**Remove & Replace Curb Ramp With Two New Directional Ramps or Equivalent.**

**R304.5.1, R304.5.3**

Total Cost: \$ 3200.00
