Access Compliance Report

Public Rights-of-Way

(Curb Ramps)

Intersection ID: N/A	Main Street: BURNETTE_AV	Cross Street: VILMA_ST	Location: SW
ADA ID: 97125EDA3A85	Ramp Type: Perp	Initial Pass/Fail: Fail	Overall Compliance: No
Severity Score: 21.25			
Codes/Mitigation Info/Possible Solution		Field Measurements/Component Compliance

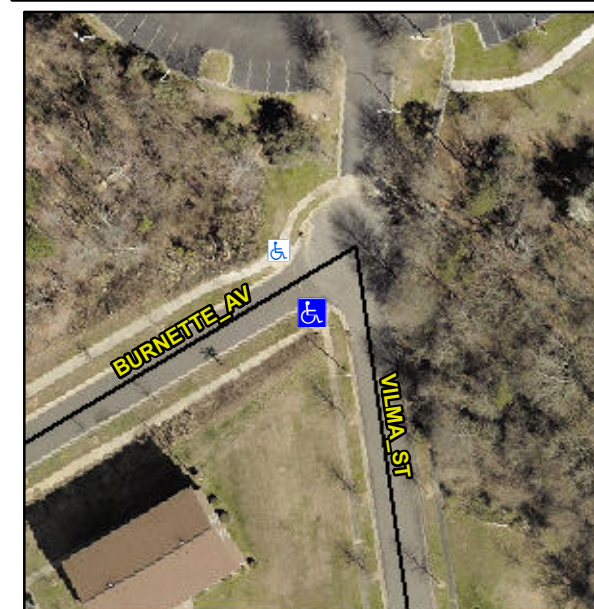
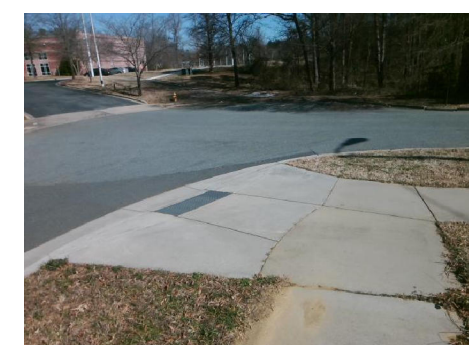
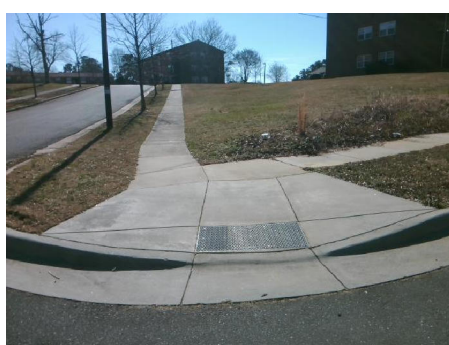
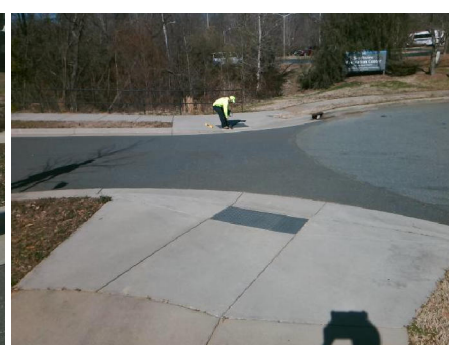
Not Found, R304.5.1, R304.2.2

Compliance	Description	Data	Compliance	Description	Data
N/A	Ramp Length (in)	98.0	No	Ramp Slope (%)	9.8
No	Ramp Width (in)	47.0	Yes	Ramp XSlope (%)	1.6
N/A	Flare Type LT	N/A	N/A	Flare Type RT	N/A
N/A	Flare Slope LT (%)	N/A	N/A	Flare Slope RT (%)	N/A
N/A	Flare Traversable LT?	N/A	N/A	Flare Traversable RT?	N/A
N/A	Landing Length (in)	N/A	N/A	DWS Provided?	N/A
N/A	Landing Width (in)	N/A	N/A	DWS Contrast?	N/A
N/A	Landing Slope (%)	N/A	N/A	DWS Length (in)	N/A
N/A	Landing X Slope (%)	N/A	N/A	DWS Full Width?	N/A
N/A	Landing Curb? (Y/N)	N/A	N/A	DWS Offset (in)	N/A
N/A	Shared Landing?	N/A			
N/A	Gutter Ponding?	N/A	N/A	Gutter Slope (%)	N/A
N/A	Gutter Lip Ht (in)	N/A	N/A	Gutter X Slope (%)	N/A
N/A	Painted X Walk1?	No	N/A	Painted X Walk2?	N/A
	X Walk 1 Direction	To N		X Walk 2 Direction	N/A
N/A	X Walk 1 Width (in)	N/A	N/A	X Walk 2 Width (in)	N/A
	X Walk 1 Slope (%)	4.3		X Walk 2 Slope (%)	N/A
	X Walk 1 X Slope (%)	2.7		X Walk 2 X Slope (%)	N/A

N/A	Ramp inside XWalk1?	N/A	N/A	Ramp inside XWalk2?	N/A
	Road Slope (%)	N/A	N/A	Clear Space?	N/A
	Road X Slope (%)	N/A	N/A	Clear Space to XWalk (in)	N/A
N/A	Any Obstructions?	N/A	N/A	Storm Grate/Utility Hazard?	N/A
	Obstruction Type			Storm Grate/Utility Type	
		N/A			N/A
			Yes	Surface Condition? (G/P)	Good

Remove & Replace Entire Ramp.
