Access Compliance Report

Public Rights-of-Way

(Curb Ramps)

| Intersection ID: 11058 | Main Street: N_I-77_EXIT_10B_RA | Cross Street: W_5TH_ST | Location: W |

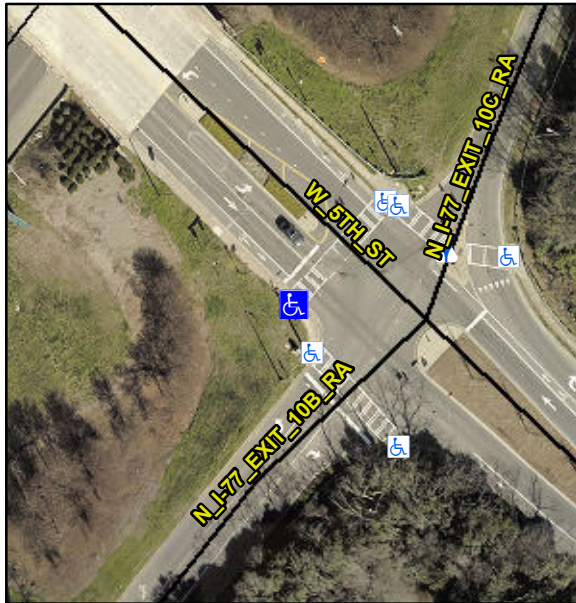
| Compliance | Description | Data | Compliance | Description | Data |
|---|---|---|---|---|---|
| Yes | Ramp Slope LT (%) | 5.8 | No | Ramp Slope RT (%) | 8.8 |
| No | Ramp XSlope LT (%) | 2.6 | Yes | Ramp XSlope RT (%) | 1.7 |

Remove & Replace Entire Ramp.
