Access Compliance Report

Public Rights-of-Way

(Curb Ramps)

Intersection ID: 10028913	Main Street: IDLEWILD_RD_NORTH	Cross Street: N/A	Location: SW
ADA ID: 9718F153EE11	Ramp Type: PerpDiag	Initial Pass/Fail: Fail	Overall Compliance: No
Codes/Mitigation Info/Possible Solution		Field Measurements/Component Compliance	
Severity Score: 25

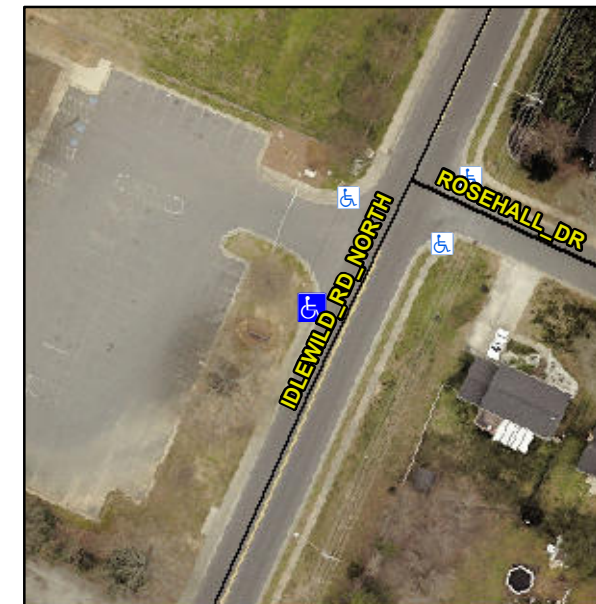
Compliance	Description	Data	Compliance	Description	Data
N/A	Ramp Length (in)	28.0	No	Ramp Slope (%)	15.7
Yes	Ramp Width (in)	48.0	Yes	Ramp XSlope (%)	0.0
N/A	Flare Type LT	N/A	N/A	Flare Type RT	N/A
N/A	Flare Slope LT (%)	N/A	N/A	Flare Slope RT (%)	N/A
N/A	Flare Traversable LT?	N/A	N/A	Flare Traversable RT?	N/A
N/A	Landing Length (in)	N/A	N/A	DWS Provided?	N/A
N/A	Landing Width (in)	N/A	N/A	DWS Contrast?	N/A
N/A	Landing Slope (%)	N/A	N/A	DWS Length (in)	N/A
N/A	Landing X Slope (%)	N/A	N/A	DWS Full Width?	N/A
N/A	Landing Curb? (Y/N)	N/A	N/A	DWS Offset (in)	N/A
N/A	Shared Landing?	N/A			
N/A	Gutter Ponding?	N/A	N/A	Gutter Slope (%)	N/A
N/A	Gutter Lip Ht (in)	N/A	N/A	Gutter X Slope (%)	N/A
N/A	Painted X Walk1?	No	N/A	Painted X Walk2?	No
	X Walk 1 Direction	To SE		X Walk 2 Direction	To NE
N/A	X Walk 1 Width (in)	N/A	N/A	X Walk 2 Width (in)	N/A
	X Walk 1 Slope (%)	5.6		X Walk 2 Slope (%)	1.8
	X Walk 1 X Slope (%)	2.1		X Walk 2 X Slope (%)	3.9

N/A	Ramp inside XWalk1?	N/A	N/A	Ramp inside XWalk2?	N/A
	Road Slope (%)	2.5	N/A	Clear Space?	N/A
	Road X Slope (%)	7.9	N/A	Clear Space to XWalk (in)	N/A
N/A	Any Obstructions?	N/A	N/A	Storm Grate/Utility Hazard?	N/A
	Obstruction Type			Storm Grate/Utility Type	
		N/A			N/A
			Yes	Surface Condition? (G/P)	Good

Possible Solutions:

Remove & Replace Curb Ramp With Two New Directional Ramps or Equivalent.

R304.2.2
