# Access Compliance Report

## Public Rights-of-Way

### (Curb Ramps)

Intersection ID: 13916	Main Street: CLANTON_RD	Cross Street: WEST_BV	Location: SW
ADA ID: 971A4CDC01D6	Ramp Type: Perp	Initial Pass/Fail: Fail	Overall Compliance: No
		Severity Score: 25

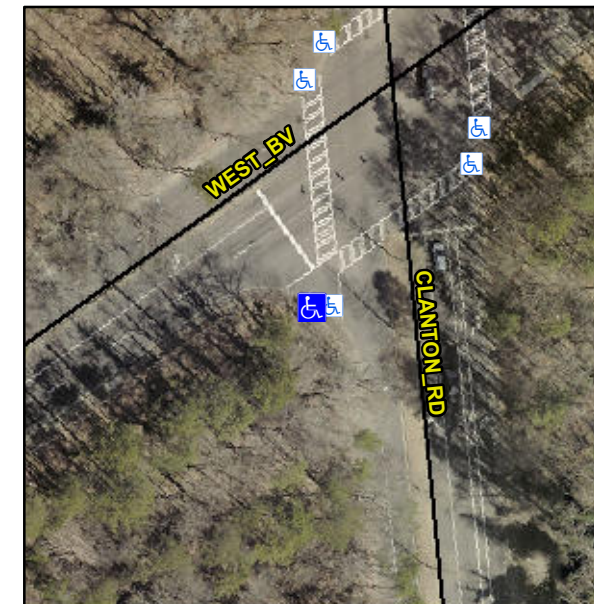
Compliance	Description	Data	Compliance	Description	Data
N/A	Ramp Length (in)	62.0	No	Ramp Slope (%)	13.3
Yes	Ramp Width (in)	60.0	Yes	Ramp XSlope (%)	1.2
N/A	Flare Type LT	N/A	N/A	Flare Type RT	N/A
N/A	Flare Slope LT (%)	N/A	N/A	Flare Slope RT (%)	N/A
N/A	Flare Traversable LT?	N/A	N/A	Flare Traversable RT?	N/A
N/A	Landing Length (in)	N/A	N/A	DWS Provided?	N/A
N/A	Landing Width (in)	N/A	N/A	DWS Contrast?	N/A
N/A	Landing Slope (%)	N/A	N/A	DWS Length (in)	N/A
N/A	Landing X Slope (%)	N/A	N/A	DWS Full Width?	N/A
N/A	Landing Curb? (Y/N)	N/A	N/A	DWS Offset (in)	N/A
N/A	Shared Landing?	N/A			
N/A	Gutter Ponding?	N/A	N/A	Gutter Slope (%)	N/A
N/A	Gutter Lip Ht (in)	N/A	N/A	Gutter X Slope (%)	N/A
N/A	Painted X Walk1?	Yes	N/A	Painted X Walk2?	N/A
	X Walk 1 Direction	To N		X Walk 2 Direction	N/A
N/A	X Walk 1 Width (in)	120.0	N/A	X Walk 2 Width (in)	N/A
	X Walk 1 Slope (%)	7.4		X Walk 2 Slope (%)	N/A
	X Walk 1 X Slope (%)	1.5		X Walk 2 X Slope (%)	N/A

N/A	Ramp inside XWalk1?	No	N/A	Ramp inside XWalk2?	N/A
	Road Slope (%)	N/A	N/A	Clear Space?	N/A
	Road X Slope (%)	N/A	N/A	Clear Space to XWalk (in)	N/A
N/A	Any Obstructions?	N/A	N/A	Storm Grate/Utility Hazard?	N/A
	Obstruction Type			Storm Grate/Utility Type	
		N/A			N/A
		Yes		Surface Condition? (G/P)	Good

**Remove & Replace Entire Ramp.  
Restripe Crosswalk.**

**R304.2.2**
