Access Compliance Report

Public Rights-of-Way

(Curb Ramps)

Intersection ID: 14366	Main Street: E_KINGSTON_AV	Cross Street: WINTHROP_AV	Location: E
ADA ID: 972BCFBAAC10	Ramp Type: Directional1	Initial Pass/Fail: Fail	Overall Compliance: No
			Severity Score: 33.75

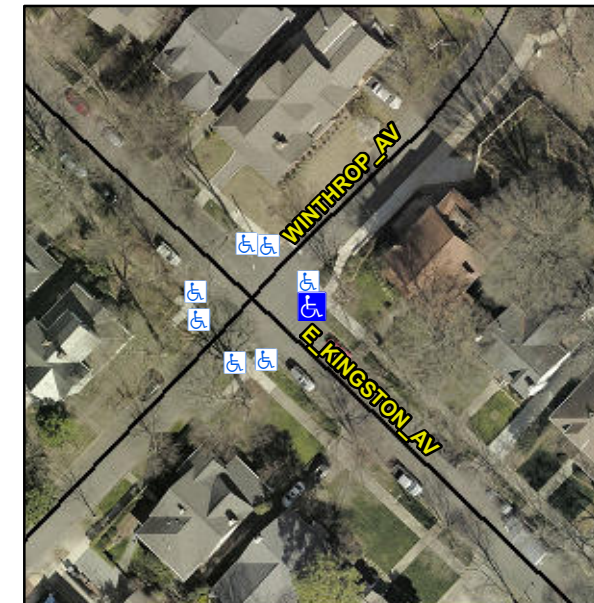
LNDG GAP 1.0"

R304.5.1, R304.2.2, R304.5.3

Compliance	Description	Data	Compliance	Description	Data
N/A	Ramp Length (in)	55.0	N/A	Grade Break?	N/A
No	Ramp Width (in)	36.0	N/A	Grade Break Slope (%)	0.0
No	Ramp Slope (%)	9.3	N/A	Grade Break XSlope (%)	0.0
No	Ramp XSlope (%)	6.3			
N/A	Flare Type LT	N/A	N/A	Flare Type RT	N/A
N/A	Flare Slope LT (%)	N/A	N/A	Flare Slope RT (%)	0.0
N/A	Flare Traversable LT?	N/A	N/A	Flare Traversable RT?	N/A
N/A	Landing Length (in)	0.0	N/A	DWS Provided?	N/A
N/A	Landing Width (in)	0.0	N/A	DWS Contrast?	N/A
N/A	Landing Slope (%)	0.0	N/A	DWS Length (in)	N/A
N/A	Landing X Slope (%)	0.0	N/A	DWS Full Width?	N/A
N/A	Landing Curb? (Y/N)	N/A	N/A	DWS Offset LT (in)	N/A
N/A	Shared Landing?	N/A	N/A	DWS Offset RT (in)	N/A
N/A	Gutter Ponding?	0.0	N/A	Gutter Slope (%)	N/A
N/A	Gutter Lip Ht (in)	0.0	N/A	Gutter X Slope (%)	N/A
N/A	Painted X Walk1?	No		Road Slope (%)	5.8
	X Walk 1 Direction	To SW		Road X Slope (%)	2.6
	X Walk 1 Width (in)	N/A		Clear Space?	N/A

X Walk 1 Slope (%)	5.8	N/A	Clear Space to XWalk (in)	N/A
	X Walk 1 X Slope (%)	2.6	N/A	Storm Grate/Utility Hazard?	N/A
N/A	Ramp inside XWalk1?	N/A		Storm Grate/Utility Type	
N/A	Any Obstructions?	N/A			N/A
	Obstruction Type		Yes	Surface Condition? (G/P)	Good
			N/A	Curb Slope (%)	4.9

Remove & Replace Entire Ramp.
