Access Compliance Report Public Rights-of-Way (Curb Ramps)

Intersection ID: 9296 Main Street: EDDLEMAN RD **Cross Street: THOMASBORO DR** Location: N/A Initial Pass/Fail: Fail **Overall Compliance: No** 42.5 ADA ID: 97372BBA0E26 Ramp Type: Combination1 **Severity Score:**

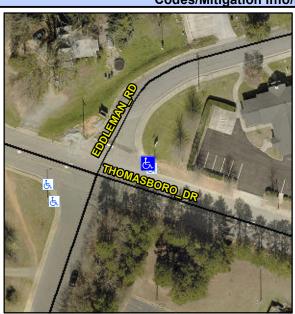
Street 1 Name None THOMASBORO DR Stop Condition-Street 1 Street 2 Name N/A Stop Condition-Street 2 N/A Possible Solutions: Compliance Description N/A Remove & Replace Entire Ramp. No No No N/A No Surveyor Notes: N/A NO RT SW, RT RP < 5% N/A N/A N/A N/A PROW/ADA: N/A R304.5.1, R304.5.1, R304.5.3, N/A R304.3.2 N/A N/A N/A N/A N/A
